# HISTORIC STRUCTURE REPORT

## THE WRIGHT TAVERN 1747 CONCORD, MASSACHUSETTS

### Groundroot Preservation Group

**Produced for First Parish in Concord, 2014**

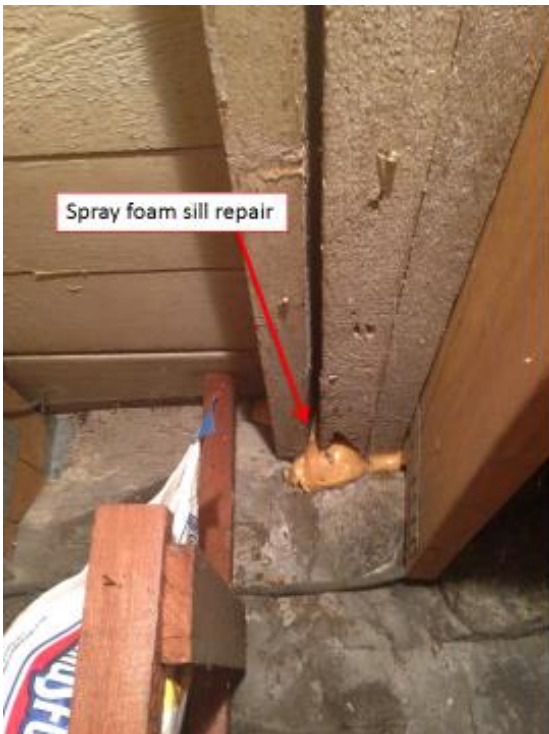
The grade is slightly downhill toward the building from the nearby driveway and Church parking lot, which will cause some drainage in that direction. There are, however, no signs of adverse effects on exterior elements. The granite front step tips slightly away from building, resulting in good drainage. However, we observed decay toward the mid-span of the east sill that is the result of water penetration from negative drainage in the past. The area has been filled with insulating spray foam. There does not appear to be active decay. This stopgap repair should be removed, the damaged area more closely inspected, and then a repair done using a wood graft and/or an epoxy resin procedure.

**Figure 8: Detail of east foundation wall showing spray-foam repair**

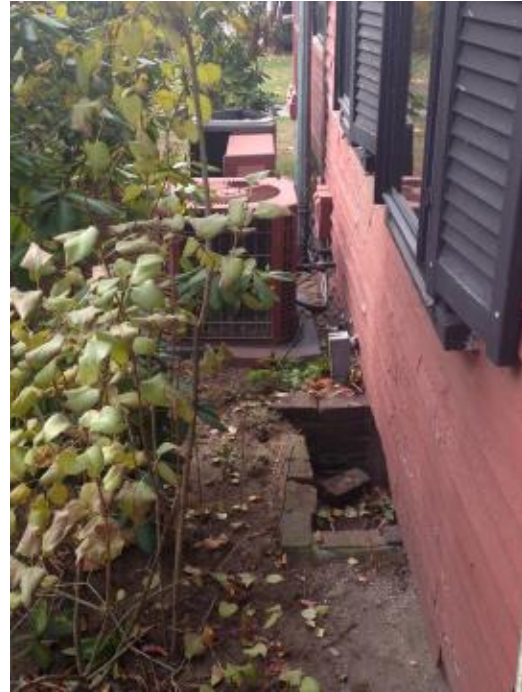
The foundation consists of fieldstone painted red. Very little is exposed above grade. Vegetation encroaches along the foundation, potentially trapping moisture and blocking the drying effect of sunlight.

**Figure 9: East elevation looking south, showing encroaching vegetation.**

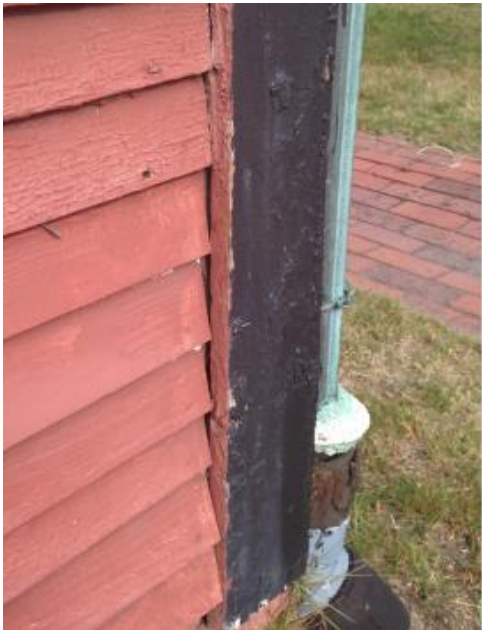
The clapboard siding on the building retains many areas of intact eighteenth-century material, but with some recent replacements to lower courses and the north corner. The north corner board is an original element, but the bottom portion has been replaced. This corner board is deflected, and the heads of some forged nails used to fasten it are protruding. The corner board needs to be carefully re-secured and the gap between the siding and corner board closed.

**Figure 10: Northeast corner board showing deflection and protruding nails.**

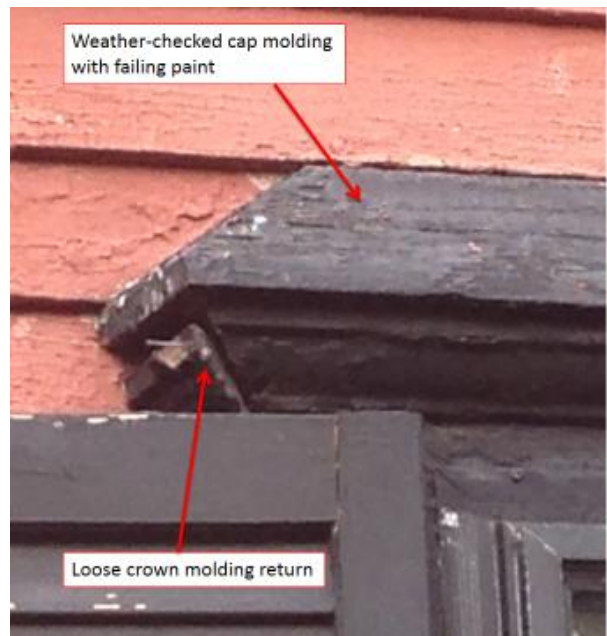
The window caps on this elevation, wooden with ovolo crowns, are predominantly original. There is extensive wear, cracking and weather checking on the caps. The two windows on the southern side having loosening and missing crown returns. Each window is fitted with an aluminum storm and screen fixture. The frames all have many layers of paint over weather-checked wood.

**Figure 11: Detail of first-floor window on east elevation showing typical paint failure and deflected woodworking joints.**

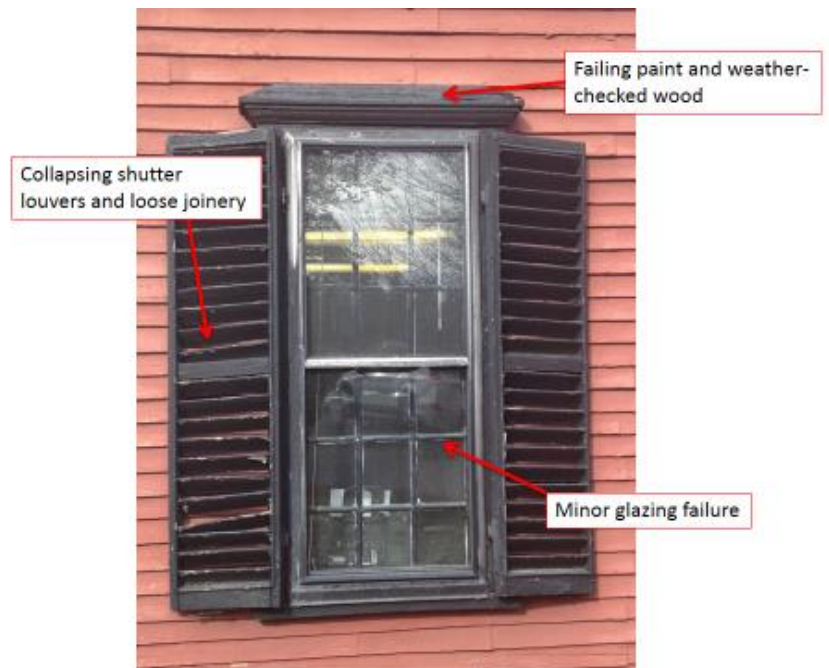
The other shutters on this elevation were probably added to the building in the early nineteenth century. They are all badly deteriorated. While salvageable, they would be prohibitively expensive to restore. We recommend they be removed and stored until a decision is made whether to restore them or have reproductions made. The two shutters on the lower south windows are recent, wooden commercial replacements fastened to the building with deck screws.

**Figure 12: Typical shutter and window conditions.**

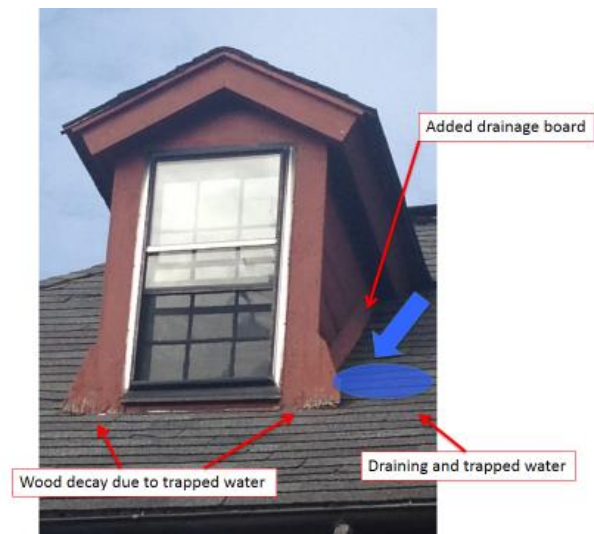
The dormer components on the east elevation consist of original framing, sheathing and windows, but with faux consoles and eaves extensions installed in the twentieth century. The matchboard siding on the cheeks is original and in generally sound condition. However, the added faux consoles exhibit extensive rot at the bottoms. The consoles are very poorly designed, as the feet trap draining water and cause rot. The ledger boards along the intersection of the roof and the dormers were probably added to cover up rot. The north dormer exhibits rotted sheathing at the bottom from water trapped by the console.

**Figure 13: Northeast dormer showing water drainage, moisture trapped behind console foot, and wood rot.**

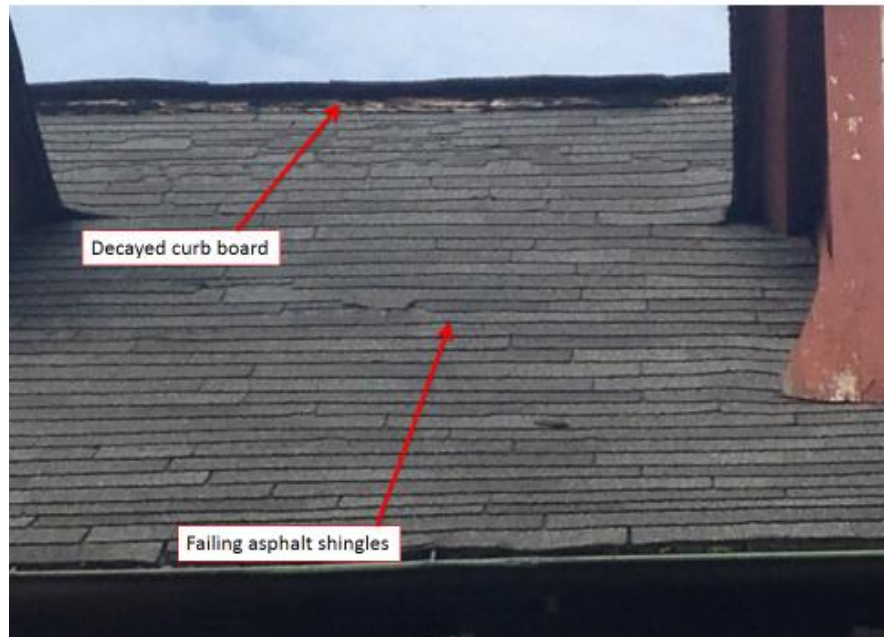
The curb, or the horizontal trim piece separating the upper and lower slopes of the roof, is made of wood. It does not appear to be original, instead being a twentieth-century replacement. It does not appear to ever have been painted and is badly weathered and deflected. This detail should be replaced using high-quality wood as a part of a greater roof replacement project.

**Figure 14: Typical roof conditions.**

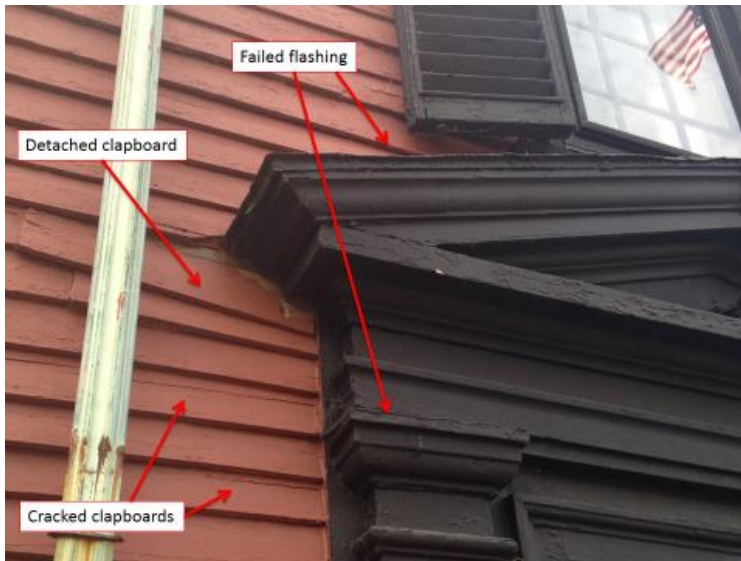
Much like the east entrance, the door is protected from the elements by a modern aluminum storm door. The surrounding woodwork exhibits thick accumulations of paint, and some areas show cracking and weather checking. The galvanized metal flashing along the pediment roof is deteriorated and not performing adequately.

**Figure 15: Detail north elevation.**

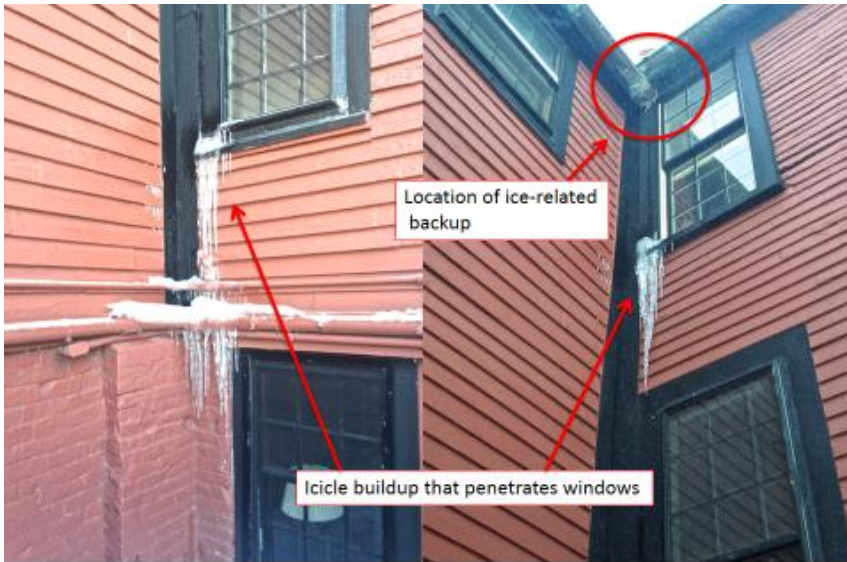
The gutter assembly on the west elevation of the main house where it connects to the south elevation of the ell shows chronic leakage and overflow. In the winter this situation generates severe icicle buildup that affects the windows associated with rooms 103 and 203.

**Figure 16: Gutter assembly – west elevation.**  
(See also Figure 27.)

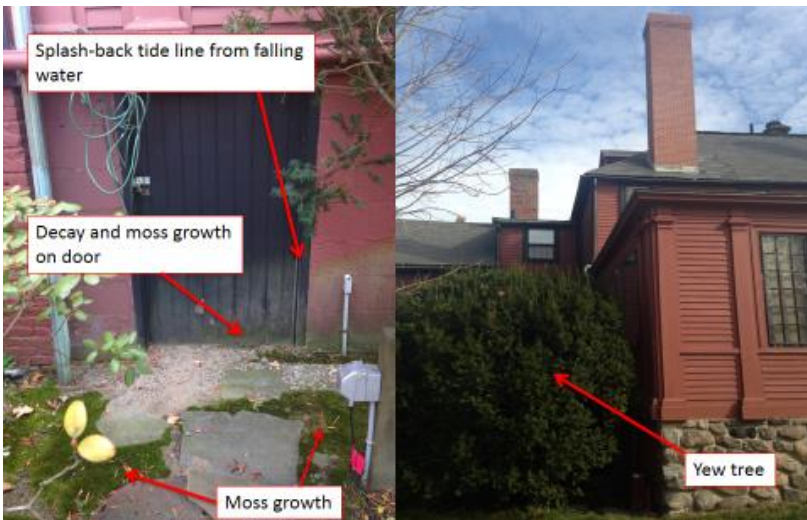
There is a bank of five outward-opening casement windows, all of which are protected by single-pane, aluminum storm units. There are two paired storms for the outer window bays and one single unit in the middle. There is minor paint failure but no significant decay in the windows despite moisture build-up caused by the encroaching yew tree.

**Figure 17: Two views of the west elevation showing encroachment of the yew tree and the effects of trapped moisture.**

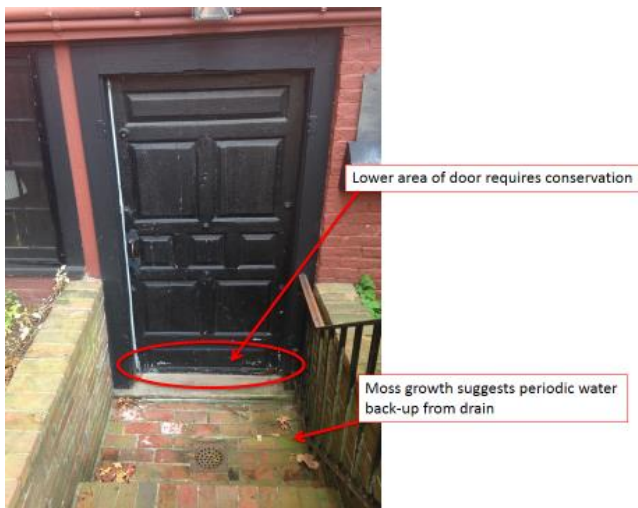
**Figure 18: View of the historic Main Street bake shop entrance on the west elevation showing recessed entry, drainage problem, and rare eighteenth-century door.**

defects, and if problems persist, the brick pavement should be removed and replaced

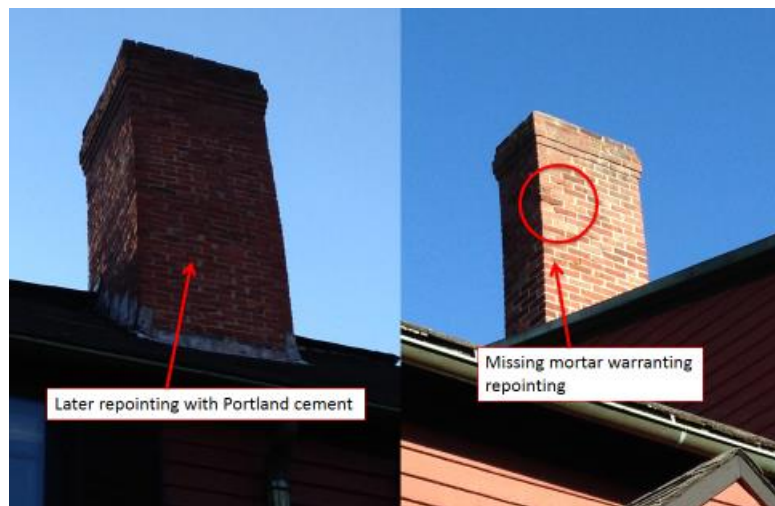
The chimney on the addition is also somewhat deflected and badly repointed with a hard, whitish mortar. Some of bricks may be replacements of the originals. This chimney may need some minor repointing in the short term, but may require removal and reconstruction above the roof line within the next twenty years.

**Figure 19: View of main and ell chimneys. Left: Main chimney showing irregular lines from settling, and later repairs. Right: Ell chimney showing mortar loss that requires repointing.**

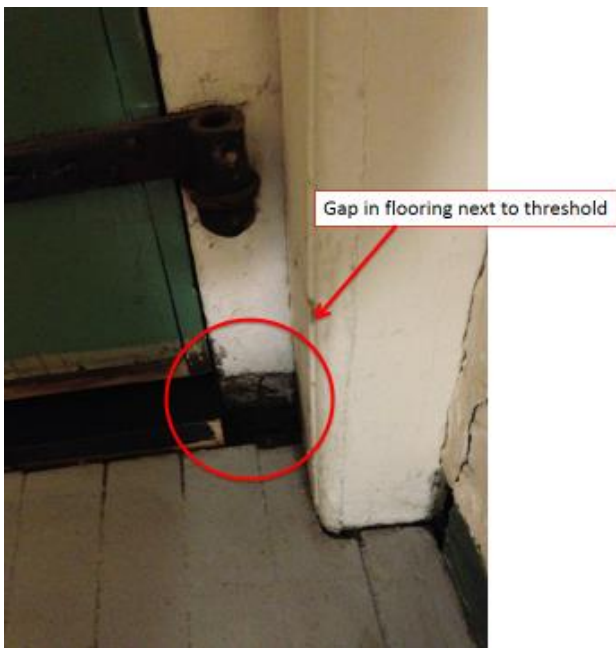
hand-forged iron latch on the exterior may be original eighteenth-century material. The forged iron keeper on the jamb may be an original component of the latch assembly. The latch bar and staple have been replaced with new, poor-quality components. The footprint showing the location of the original latch bar is visible on the back of the door. The sliding bolt and lock are also recent, inexpensive additions. The door threshold looks recently replaced. It does not fit the opening in the flooring left by the previous threshold, so there are gaps on either side of the inside exposure of the threshold. The earlier threshold had sill horns or returns that filled the gaps at the bottom of the inside trim. Gaps on either side of the threshold between the edge of the flooring and the door trims should be filled in with wood grafts.

**Figure 20: South end of east door threshold showing a gap that needs to be filled in.**

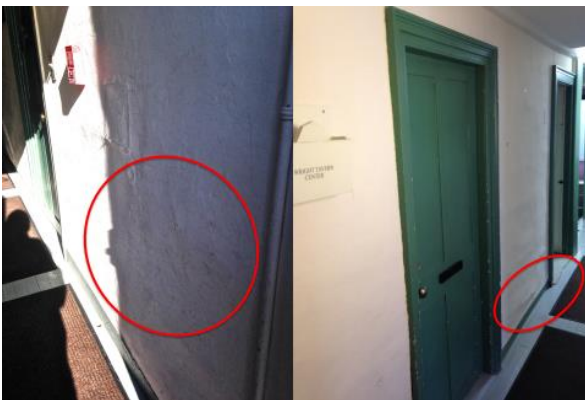
There are two areas of concern in the wall plaster in this space. An area of buckling and detachment is located in the north wall near the east entrance. This may have been caused over time by people entering the building, perhaps with heavy or large delivery packages, bumping against the wall. There is also a pronounced buckle from settling toward the bottom of the south wall, above the baseboard, between the doors to 102 and 106. Animal hair binder is visible in a crack, so the wall plaster here may be early. This buckle and crack should be stabilized with acrylic consolidant injections by an architectural conservator or someone who has been trained in this work.

**Figure 21: Two views of the east entrance hall looking west. Left: North wall near entrance. Right: South wall between doors to rooms 102 and 105. Red circles show the area of plaster to be consolidated.**

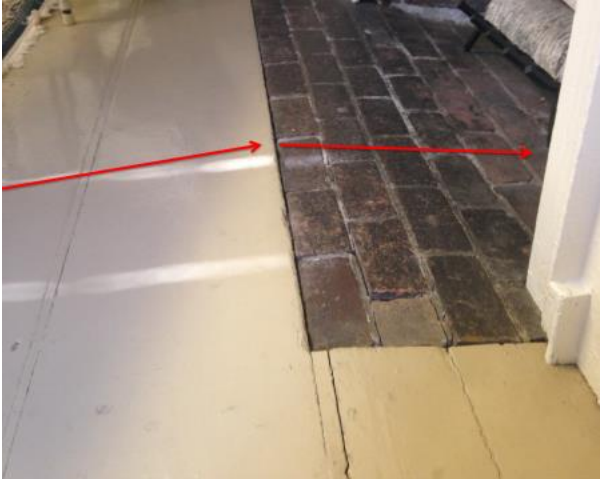
**Figure 24: View of Room 101 floor and hearth showing deflection related to prior settling.**

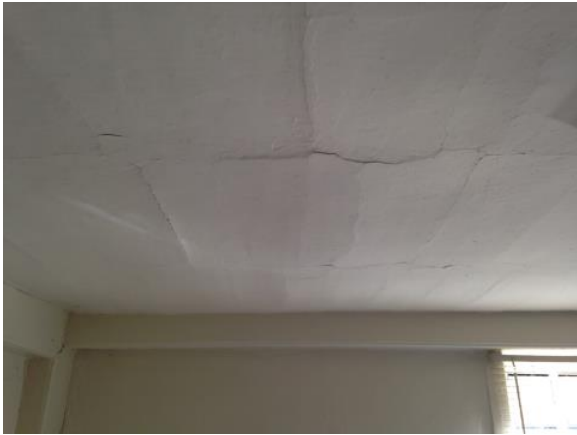
The north and east walls retain a great deal of old, perhaps original plaster. The ceiling exhibits widespread cracks, separation from lath, and sagging. The northern half of the ceiling is the most precarious, with many active cracks and pronounced sagging, signaling loss of key with the lath substrate. When palpated, many areas move under the hand. This material is in danger of collapse and should be repaired using acrylic injections to reattach the material to the lath. This is the most sensitive as well as the most inexpensive approach to treating this ceiling.

**Figure 25: Ceiling, room 102, showing extensive cracking and detachment from lath.**

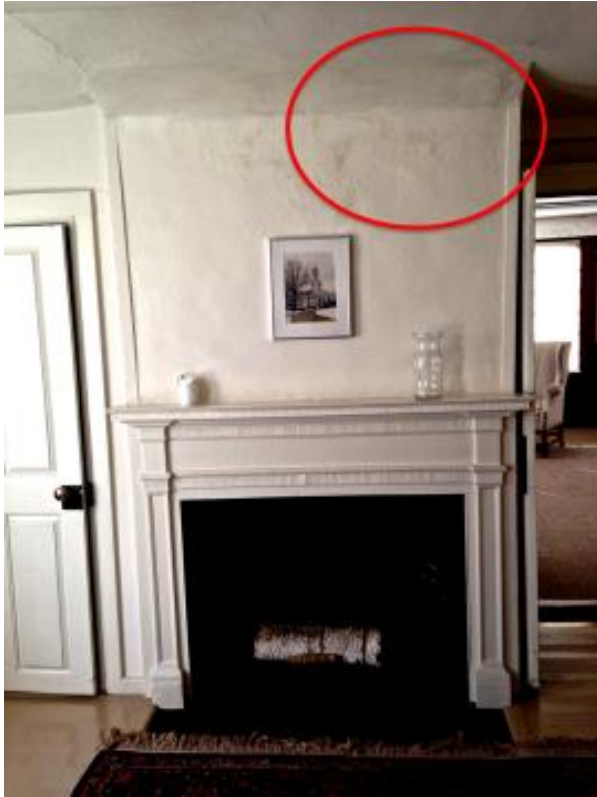
**Figure 26: View of the fireplace wall in Room 102 showing the location of paint and plaster damage from chimney-related water infiltration.**

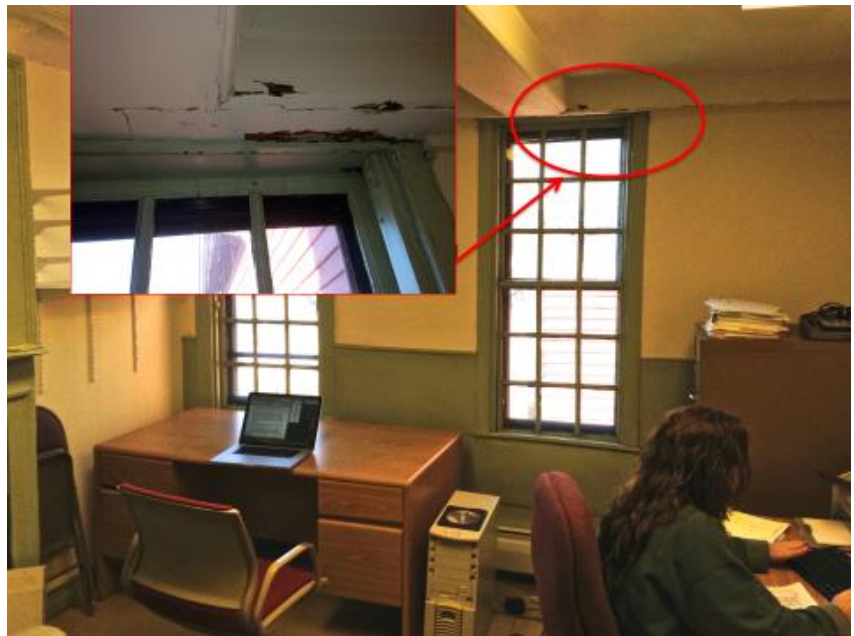
**Figure 27: View of west wall, Room 103, showing localized paint and woodwork damage related to water infiltration from above. See also Figure 16.**

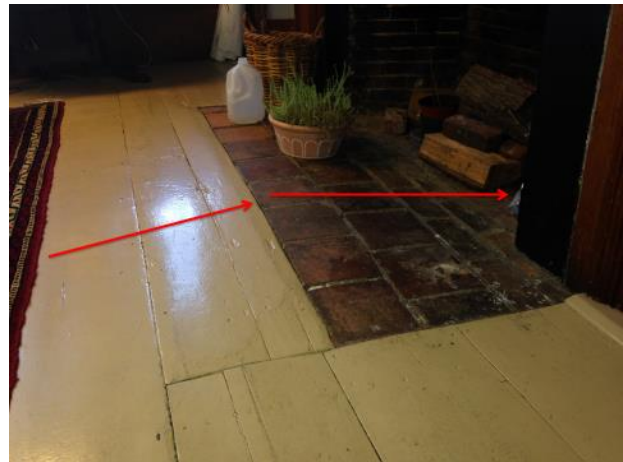
floor downward and causing upward deflection toward the center of the room.

**Figure 28: View of the fireplace hearth, Room 104, looking north, showing floor and hearth deflection.**

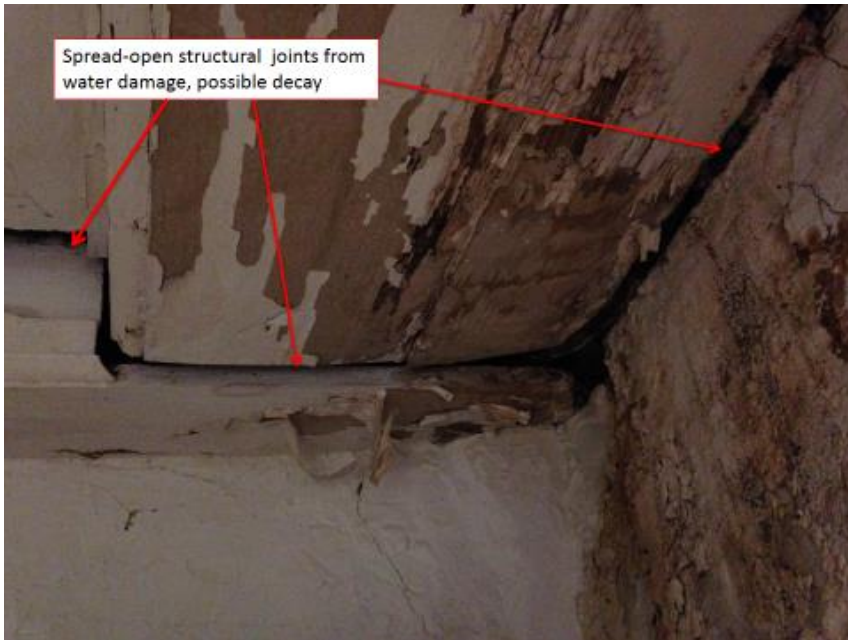
**Figure 38: Intersection of the summer beam with the south girt, seen from inside the chimney closet in Room 203.**

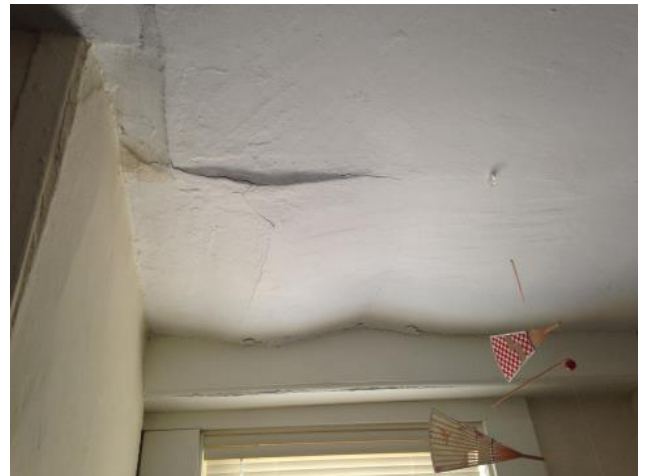
**Figure 39: Area of detached plaster to the west of the chimney breast in Room 203.**

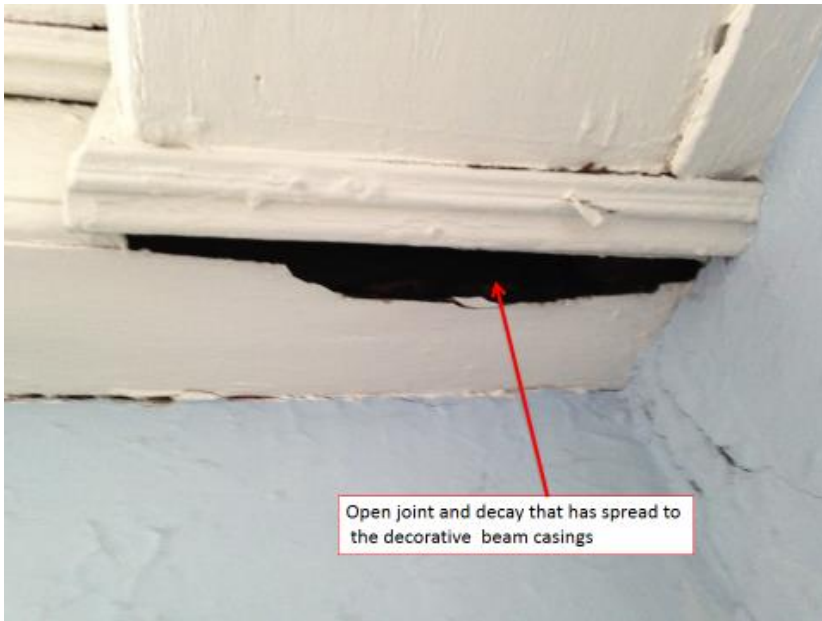
**Figure 40: Front girt plate and girt intersection showing a spread-open joint and wood decay related to water infiltration.**

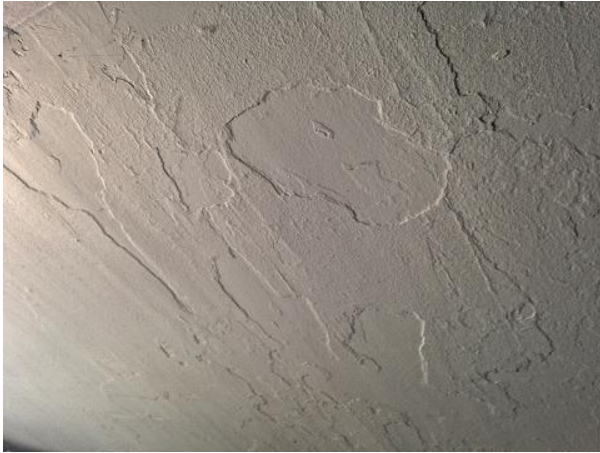
**Figure 41: Paint failure in Room 209 related to poor adhesion over underlying calcimine.**

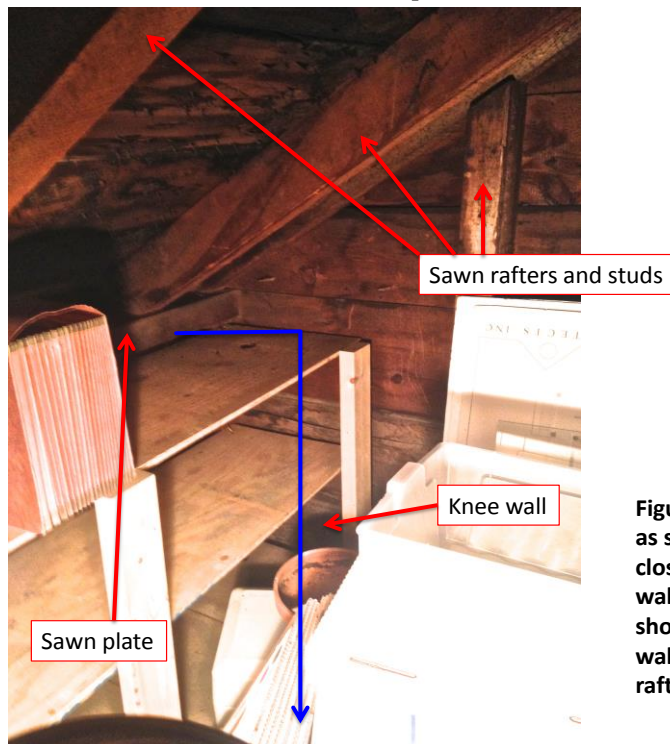
**Figure 42:** Ell framing, as seen from the closet in the south wall of Room 209 showing added knee wall and replacement rafters.

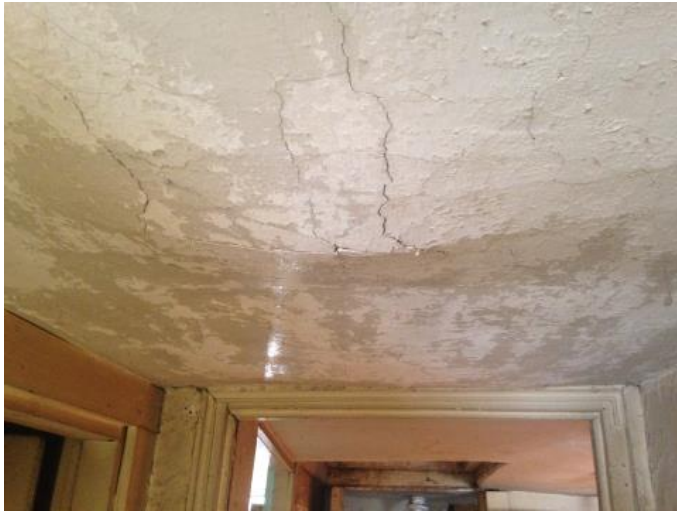
**Figure 44: Failing ceiling plaster in 300c requires stabilization.**

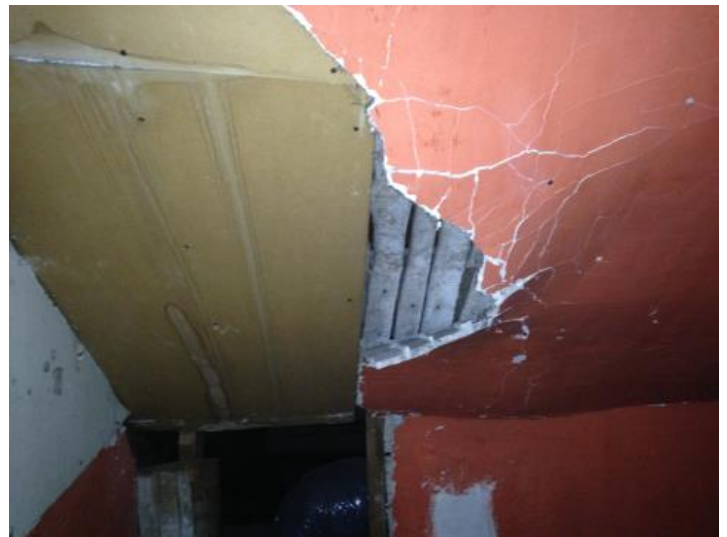
**Figure 45: Ceiling plaster in Room 301 exhibits extensive collapse.**

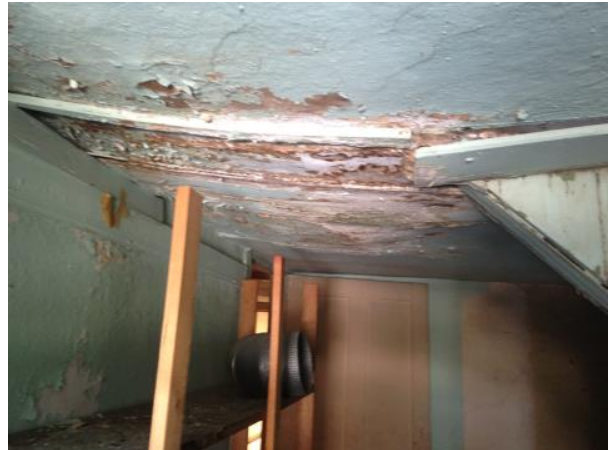
**Figure 48: The ceiling and purlin post in Room 304 exhibit a pronounced sag related to past water leaks. The wood and plaster in this area are in danger of collapse.**

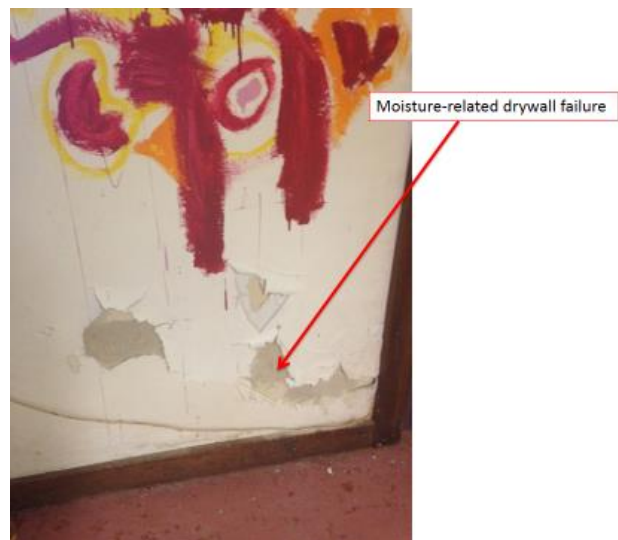
**Figure 50: Failing drywall in the basement below Room 103, the result of high moisture levels, promotes mold growth.**

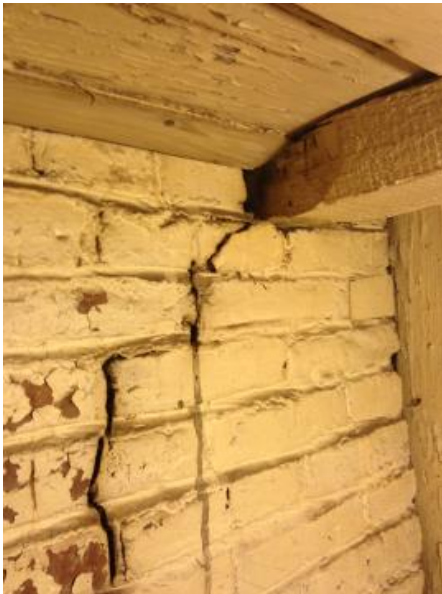
**Figure 51: Settling crack in main chimney mass masonry as seen from the basement stairwell leading from Room 104.**

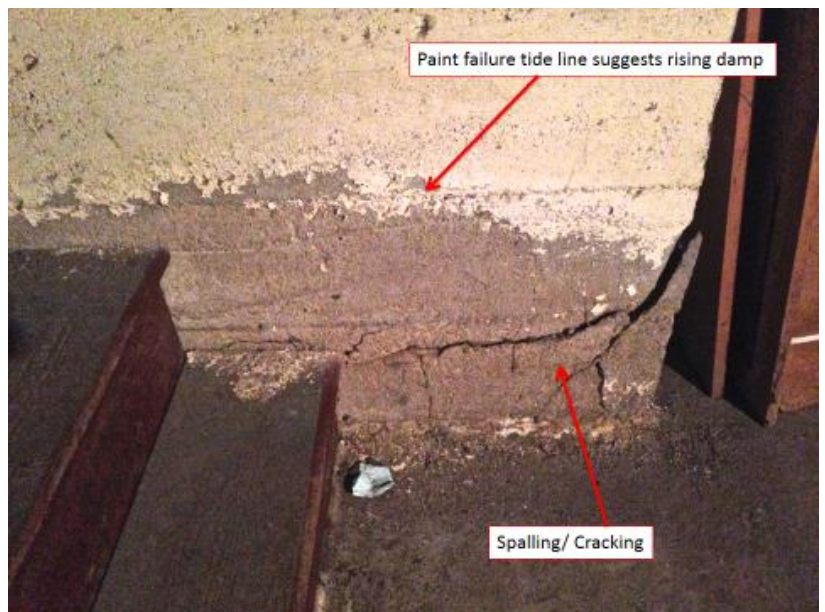
**Figure 52: concrete delamination at the base of the main chimney suggests possible beginnings of rising damp.**

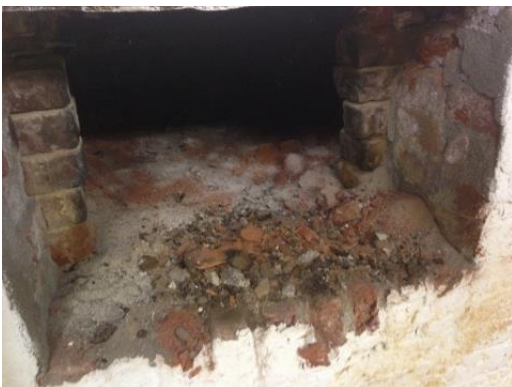
**Figure 53: Accumulations of mortar, brick and creosote debris in the bake oven suggest interior flue deterioration.**

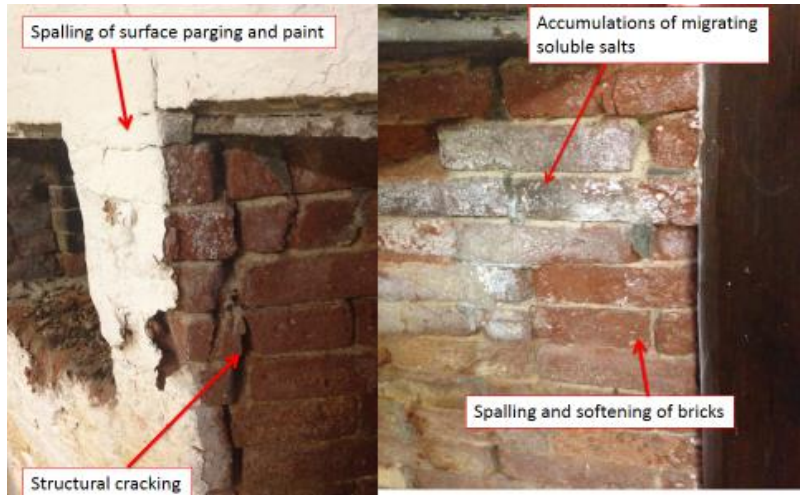
**Figure 54: Left: Structural cracking suggests loss of compressive strength in the bricks. Right: Spalling, softened bricks and the appearance of soluble salts in the firebox suggest possible rising damp concerns.**

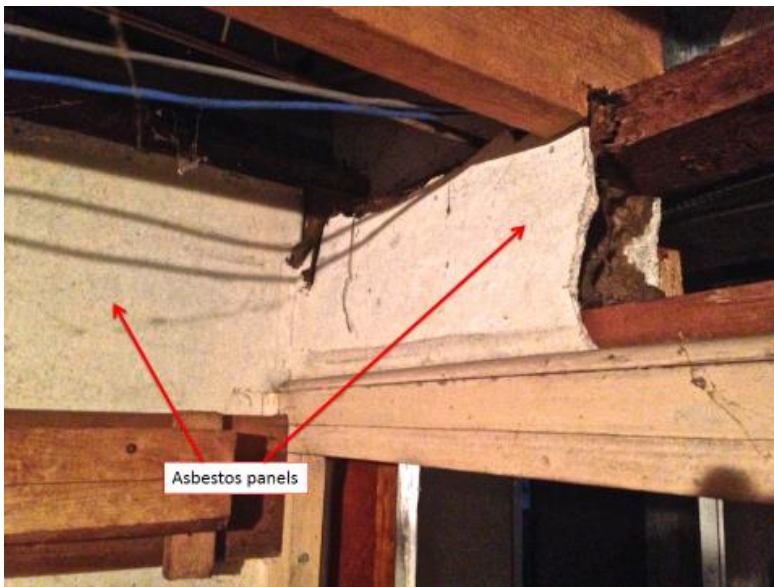
**Figure 55: The small cold storage room below Room 101 is encased in asbestos panels that require abatement.**

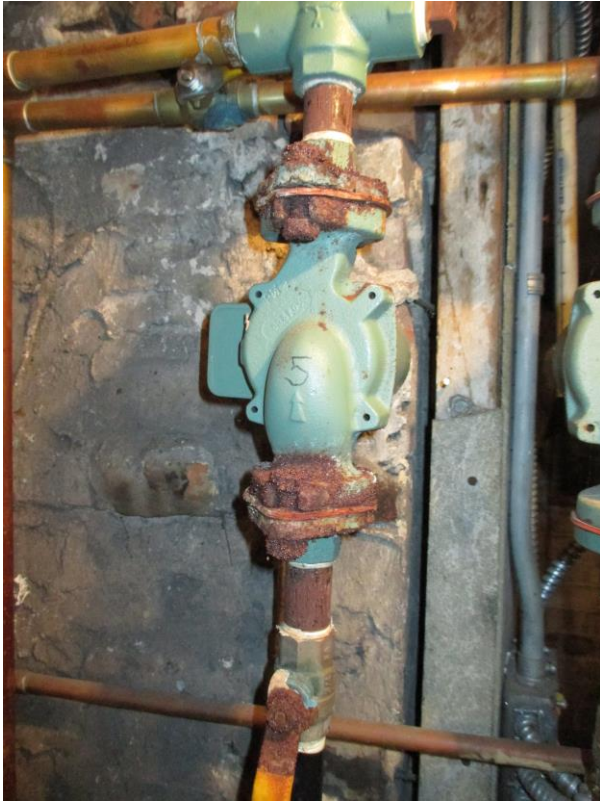
**BAS: 6 Rusted valve above the boiler.**

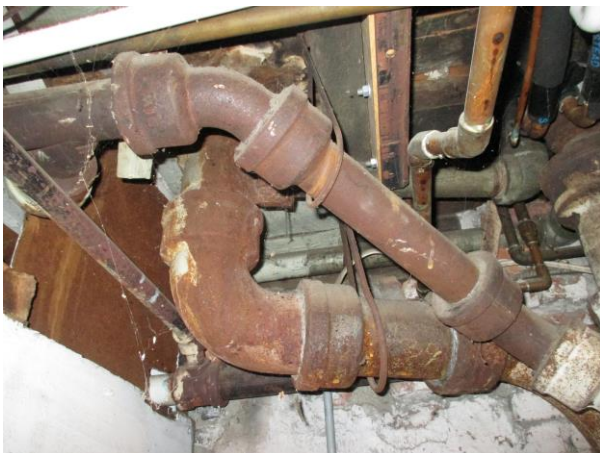
**BAS: 16 Rusted cast iron drain line east center**
