CONSULTING STRUCTURAL ENGINEER, INC.

December 12, 2019

RE: Structural Investigation and Evaluation
The Wright Tavern
6 Lexington Road
Concord, MA

CSE 05319

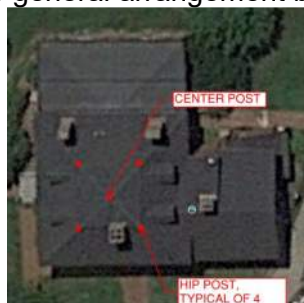
- Significant sagging of roof framing members is observed in the sloped/hip roof framed areas. (See photo #9)
 - Sagging down towards each hip post from the center post is evident. (See photo #10)
 - Past damage due to snow load and deterioration as well as miscellaneous repairs are evident within the roof framing. (See photo #4)
- B. Area 1 third/attic floor framing:
- The third/attic floor framing is completely concealed with some areas expressed through finishes. The framing consists of approximately 9x9 timber girders

1. The roof framing within the original 1747 core (Area 1) of the building requires reinforcement to support snow loads. The observed local sagging of sloping rafters is the result of snow load overwhelming the existing framing.
 - a. We recommend reinforcement of all rafters within the roof.
2. The third/attic floor framing above the second floor of the original 1747 core (Area 1) requires reinforcement to support the roof loads imposed by the four (4) hip posts. The

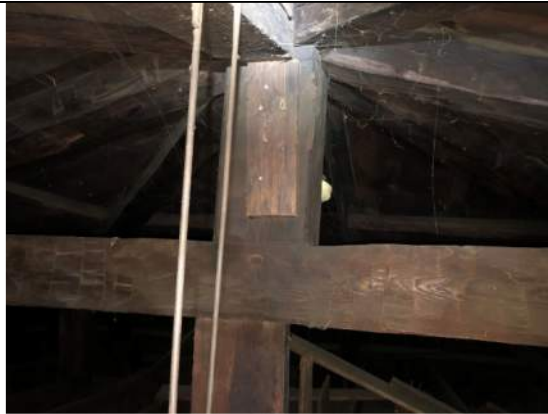
3) Center post in attic above ceiling.

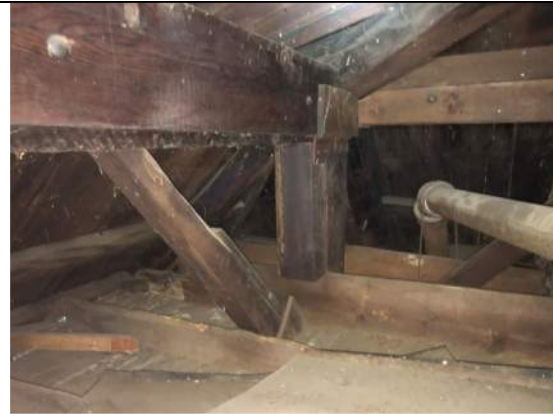
4) Typical hip post in attic above ceiling, typical of 4 locations.

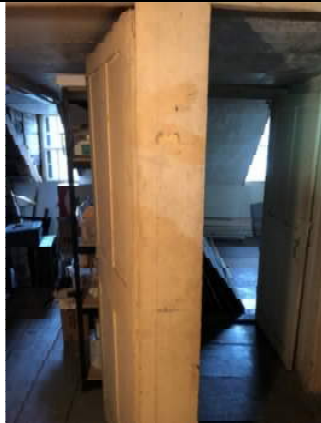
5) Continuation of center post through third/attic level.

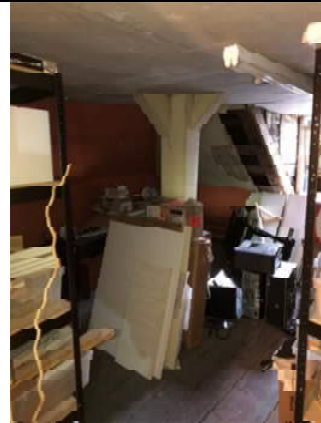
6) Continuation of hip post through third/attic level.

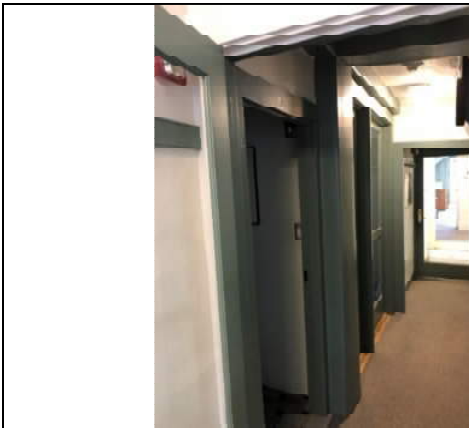
- b. A continuation of the center roof post exists through this level within the center wall. A noticeable high point in the floor occurs immediately adjacent to and around the center post, the floor slopes down in all directions from the center. (See photo #7)

7) Continuation of center post through second floor level. See photo #17 for continuation through first floor.

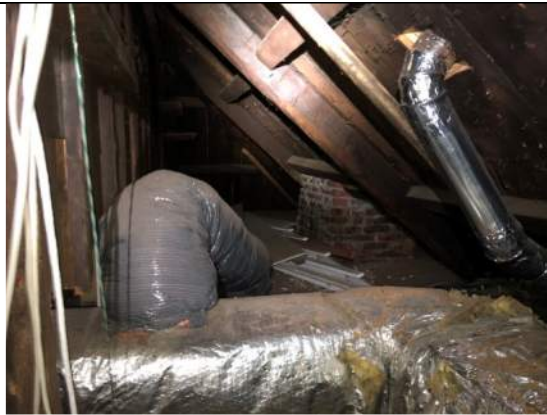
9) Sagging rafters on west facing hip roof of the original 1747 construction in area 1.

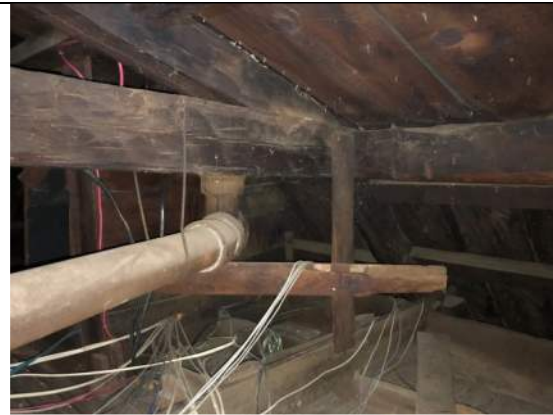
10) Sagging end of center girder at interface of hip roof at west side.

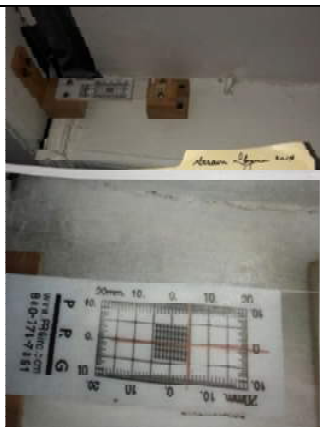
- d. A crack monitor is present on the interior finishes at the location of the timber girder as it ties into the mid-point of the east wall.
 - i. Original photographic documentation of the crack monitor at time of installation in approximately 2014 was reviewed while on site. (See photo #11)

11) Existing crack monitor on east wall at interface with center girder (top) and documented measurement from 2014.

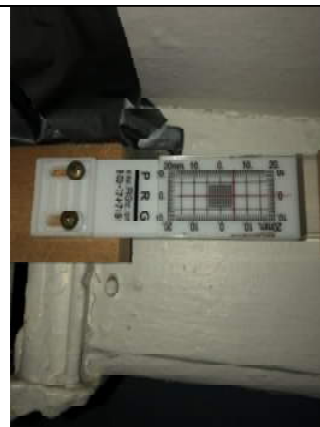
- ii. A new photograph of the crack monitor position was recorded as part of this report. (See photo #12)
 - iii. The difference between the original installed position of the monitor and the observed current position is approximately 1 millimeter more separated as read from the monitor markings. The movement of the crack indicates separation of the timber girder from the east wall.

12) Current reading of crack monitor during observation.

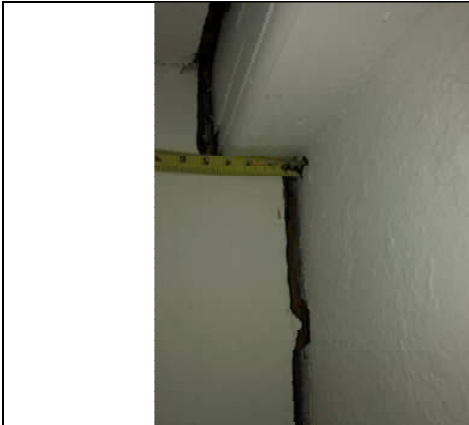
- e. Cracking and separation of the timber girder from the west wall adjacent to the northwest chimney of the second floor is observed. (See photo #13)

13) Crack in closet of second floor office on west wall at chimney.

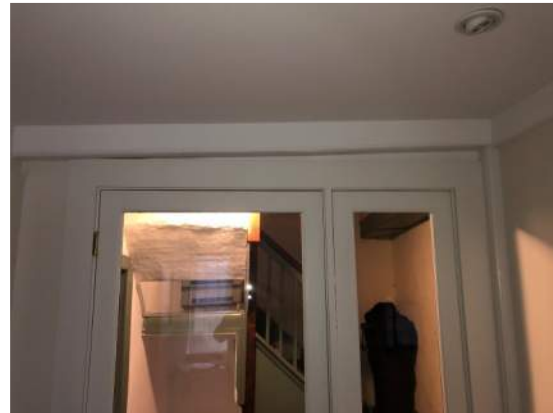
spanning 18-feet, spaced at 9-feet on center, supporting unknown smaller timber joists between them. The girders are generally sagging along their span and out of level. (See photos #8 and #14)

14) Sagging condition of timber girders typical throughout second floor ceiling.

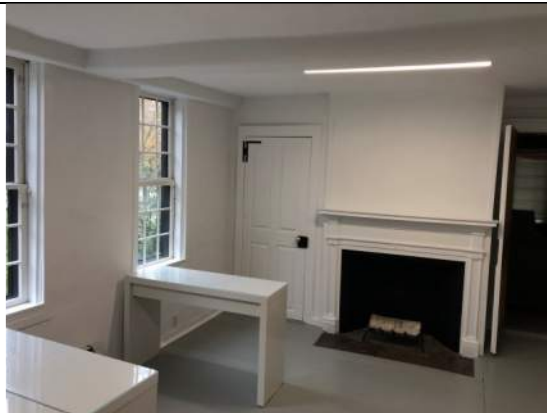
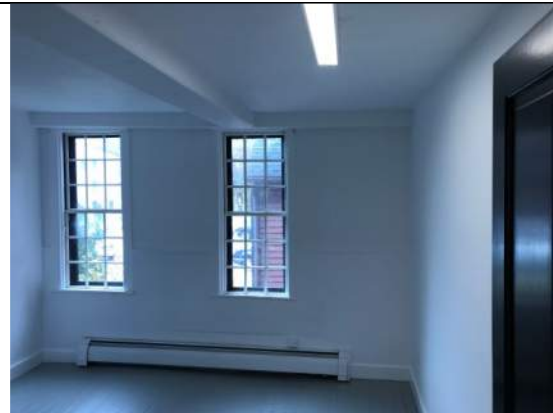
- C. Area 1 second floor framing:
- a. The second floor framing is completely concealed with some areas expressed through finishes. The framing is similar in configuration, span and size to the third/attic floor framing above. (See photos #15 and #16)

15) Exposed second floor timber beams in ceiling of first floor.

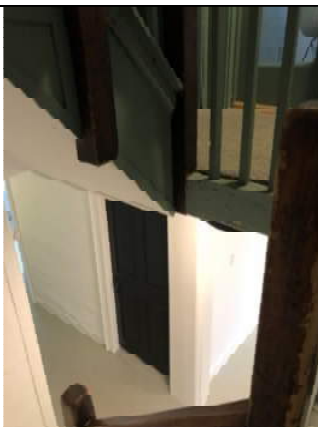
- b. A continuation of the center roof post exists through the first floor level within the center wall in the area of the bathroom/corridor wall. (See photo #17)

17) Continuation of center post through first floor level adjacent to bathroom door.

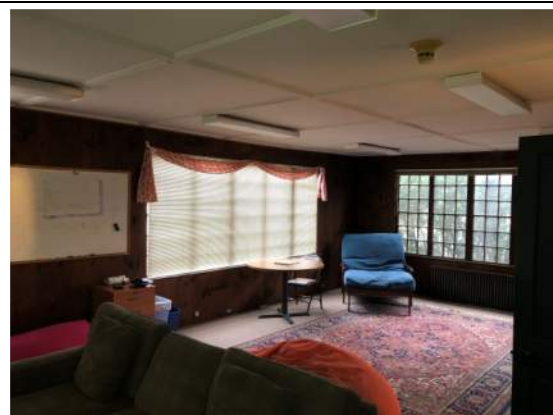
- a. The roof framing is generally low-slope/flat and not visible due to interior finishes. (See photo #18)
- b. The framed first floor consists of 2x8 joists, spanning 8-feet, spaced at 16-inches on center and supported by a 6x10 centerline beam. Lally columns spaced at approximately 9-feet on center support the center line beam to interior isolated footings. (See photo #26)
- c. The lally columns supporting the centerline beam are generally deteriorated due to moisture exposure in the crawl space. Some lally columns are no longer in contact with/supporting the centerline beam.

18) Interior of the single story area 3 under roof.

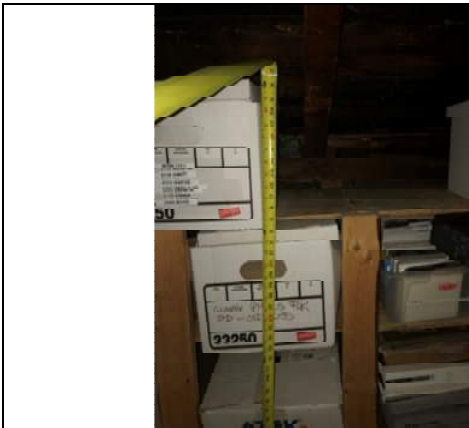
- D. Area 2 roof framing:
- a. The ridge line of area 2 has a visible sag along its length. The ridge board is not visible from the inside.
 - b. Roof rafters are 3x5 timbers at 32-inches on center, supported by balloon framed walls that extend approximately 32-inches above the second floor level. (See photo #19)

4. The observed ridge line sagging of the roof at area 2 is due to the existing rafter framing supported on a stud wall plate that is 32-inches above the floor level. The lack of ceiling ties at the rafter bearing plate allows the rafters to push out on the wall and results in the sagging rafter.

19) Area 2 roof rafter bearing on wall plate above floor level.

- a. We recommend the installation of a ridge beam under the existing ridge to stabilize the condition.
5. The observed deterioration of lally columns in the crawl space of area 3 is the result of exposure to excessive moisture in the space.

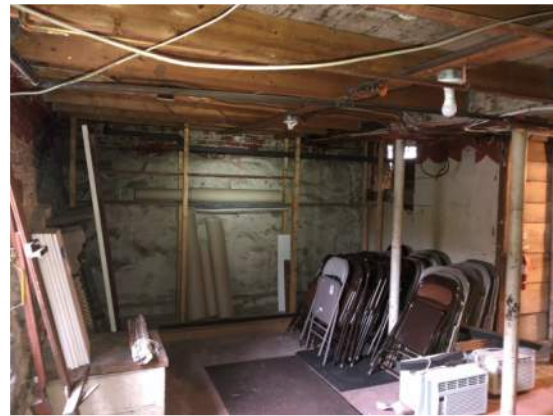
- E. Area 2 second floor framing is not visible due to interior finishes.
- F. Area 1 and 2 first floor framing:
- a. The first floor framing is a mix of original timber framing and more modern reinforcements to address damage and alterations made over time. (See photos #20 and #25)

- d. Interior supports consist of concrete filled lally columns located along timber girders and at other locations that appear to have been installed more recently. (See photos #20 and #25)

3. The observed framing of the first floor in areas 1 and 2 is the result of original undersized framing, past alterations and damage repair made by poorly done reinforcements.

20) General first floor framing in area 2.

- a. We recommend correction of the first floor reinforcements and addition of more suitable supports in the basement where warranted. This work may include one or more of the following types of work:

- i. Installation of additional beam lines with lally columns adjacent to foundation walls where joist ends are not properly supported.
 - ii. Installation of additional lally columns under existing girders.

- iii. Installation of suitable joist hangers on joist ends framing into timber girders.
 - iv. Sistering of original joist framing and/or removal and reinstallation of existing joist sisters with properly installed joist sisters.

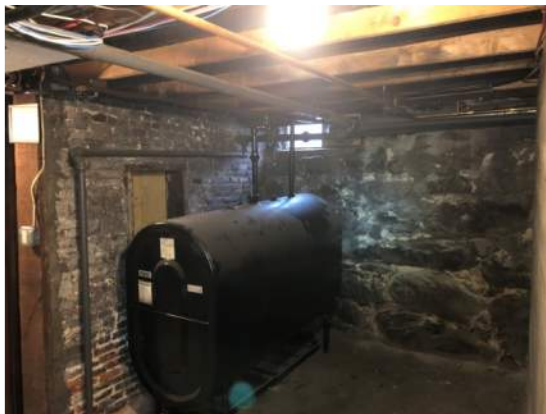
- a. Overall the foundations appear free of obvious and significant settlement concerns. Some minor settlement or movement in the past has resulted in various cracking noted in a few areas, mainly at building corners. (See photos #21, #27, #28 and #29)
- b. A more modern interior poured concrete foundation is present along the east wall of area 1 adjacent to the internal basement stair. The base of this wall has significant spalling due to moisture exposure and steel reinforcement deterioration. The purpose of this interior foundation is not fully understood, but it does support timber floor framing above it. (See photo #22)
- c. In many locations the interior brick masonry walls are eroding. (See photo #21)

6. The observed interior brick wall deterioration within area 1 and 2 is the result of soft clay brick eroding over time.
 - a. We recommend these walls are removed/replaced in locations where the interior brick walls provide necessary support of the framing above. This may be accomplished by masonry in-kind or replacement with lally columns and beams in the basement as necessary.

21) General condition of field stone wall and interior brick masonry walls.

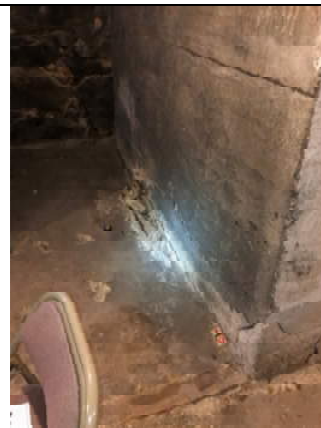
- a. We recommend that these walls are repointed and sealed at the crack locations.
8. The spalling of the interior poured concrete foundation in area 1 is due to inadequate concrete cover on reinforcing and exposure to moisture over time.

22) Spalling of interior concrete foundation at base in area 1.

- a. We recommend that the loose and unsound concrete and deteriorated reinforcing be removed, and the wall repaired with a suitable repair mortar.

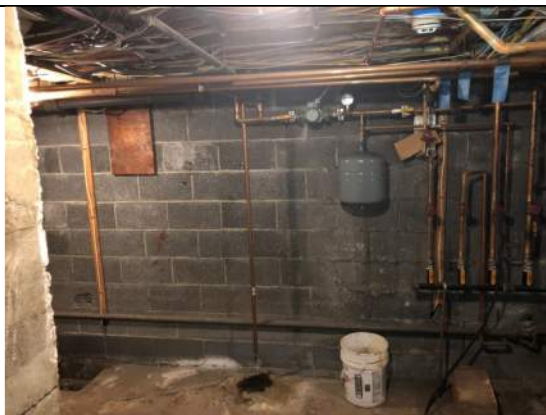
- b. Framing reinforcements in many instances are done poorly with inadequate support. (See photo #24)
 - c. A masonry wall is present under the center post location. (See photo #23)

23) Concrete masonry wall along center line in area 1 and beneath center post to roof.

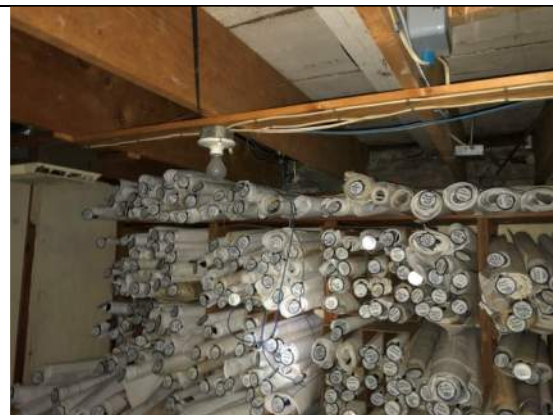
24) Sample floor joist sisters in area 1 with inadequate support at foundation wall.

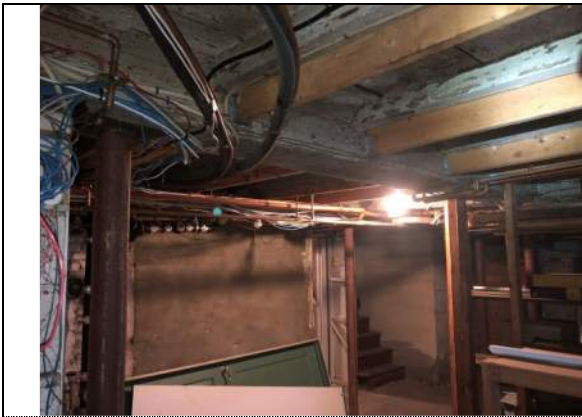
25) General first floor framing of area 1.

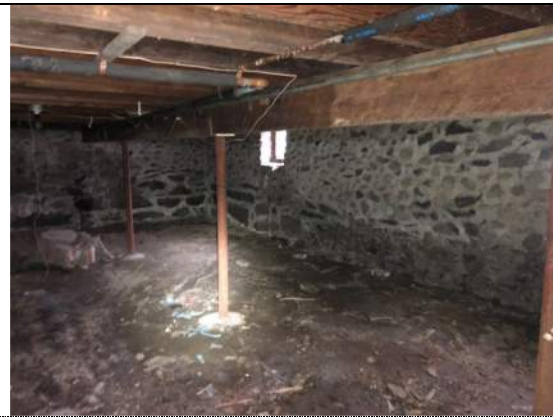
26) General first floor framing within area 3 and dirt floor crawl space, deteriorated lally columns.

- a. We recommend that the moisture is controlled in the area by installation of a moisture barrier and concrete slab-on-grade.
 - b. We recommend all lally columns are replaced with new lally columns. Expose footings as part of the work to determine the footing size/suitability, replace if warranted.

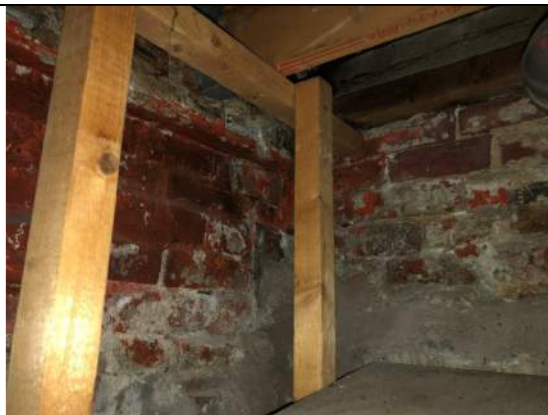
27) Interior side of wall at photo 28, no crack visible.

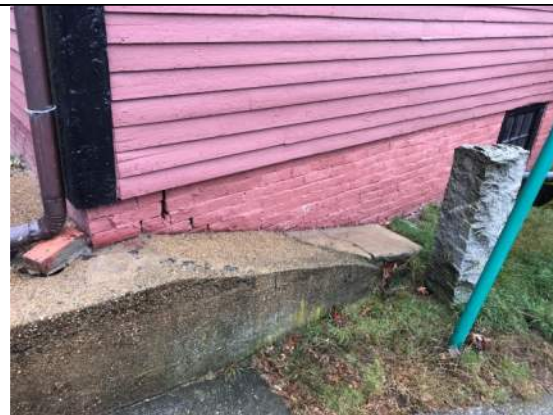
7. The observed cracking in perimeter brick masonry and stone foundation walls is the result of past minor movement, thermal movements or minor localized settlement.

28) Exterior side of wall at photo 27, crack present.

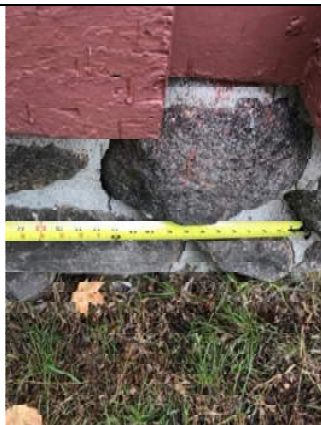
29) Exterior foundation of area 3 with visible crack.
