Warners Pond Dam

Phase I Inspection / Evaluation Report

Concord, Massachusetts

Date of Inspection: **June 9, 2023**

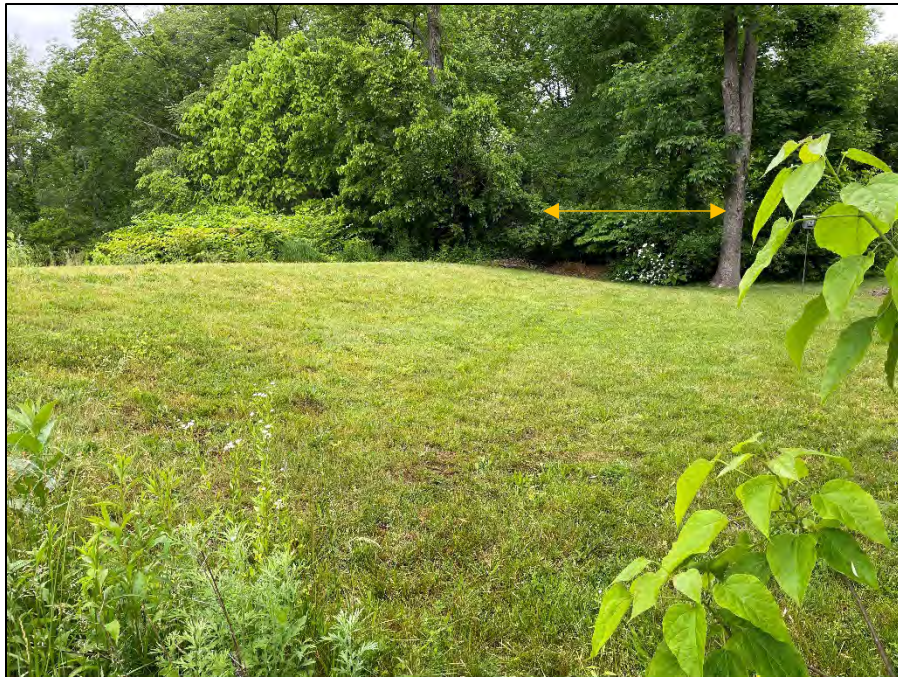
Photo No. 4.: Crest and downstream slope near 0+50 looking left. Note the apparent lower left abutment

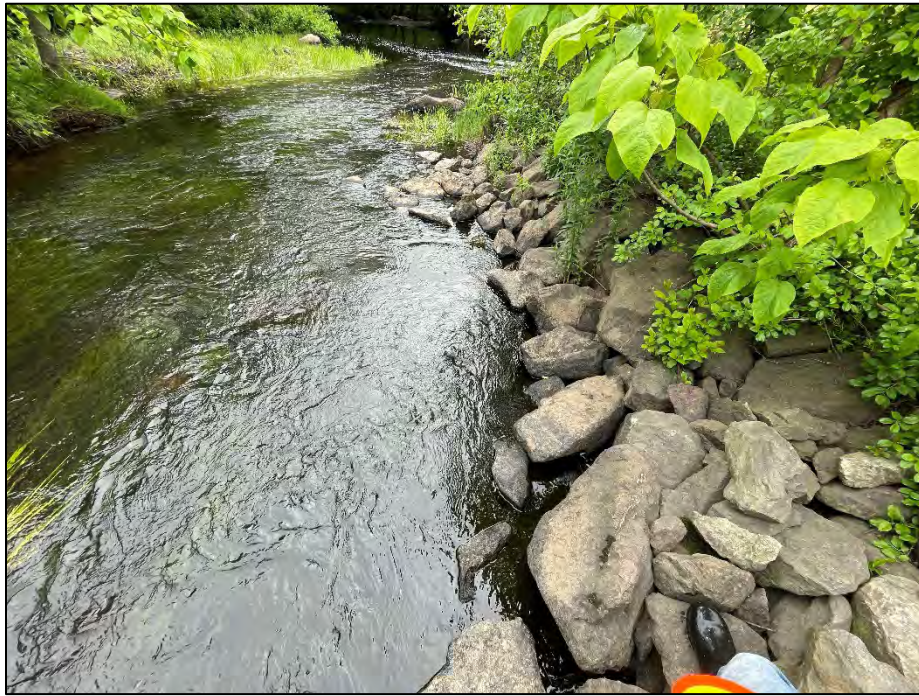
Photo No. 9.: Downstream toe of embankment between the spillway

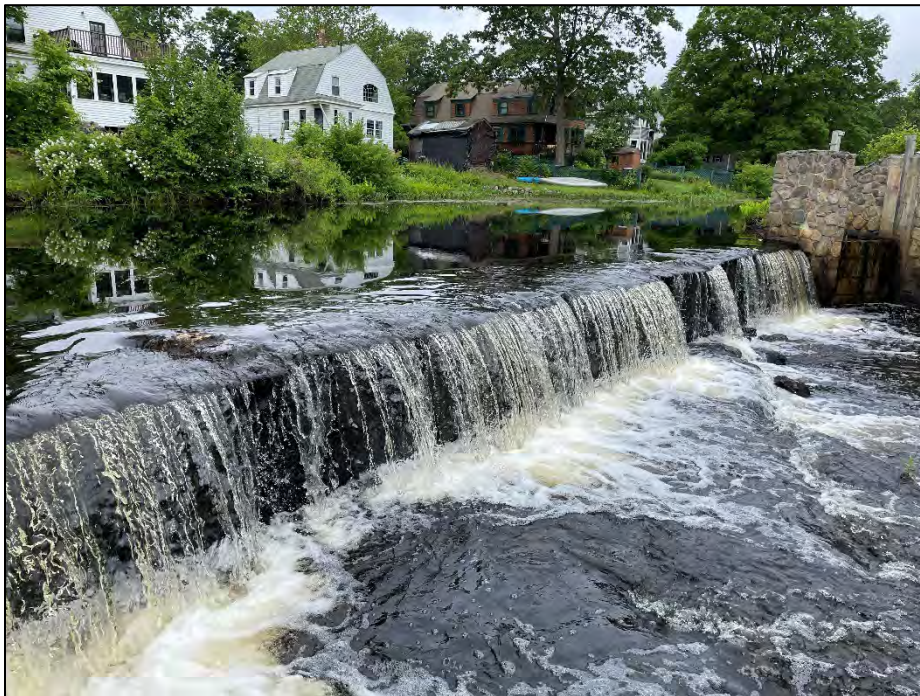
Photo No. 12.: Downstream side of the primary spillway.

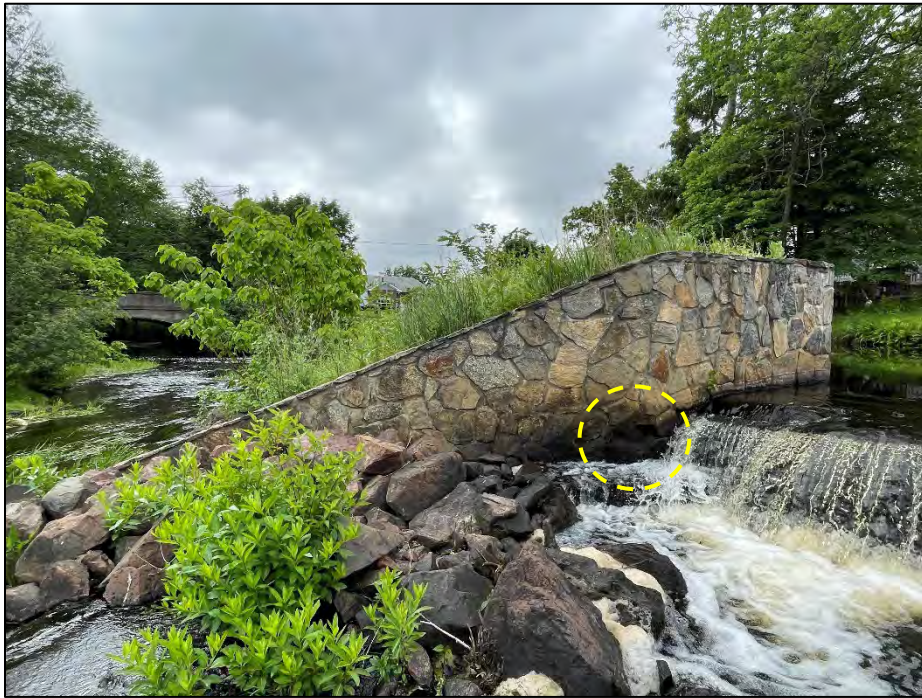
At the time of the inspection, no signs of immediate stability concern due to seepage were observed. However, the leakage observed at the right training wall of the primary spillway and previously reported at the end of the left training wall at the auxiliary spillway should be further evaluated.

Photo No. 15.: Right training wall of primary spillway. Note the location of the missing stone and the leakage through one of the masonry joints

2. Replace the dislodged stone at the right training wall of the primary spillway. Further evaluate the leakage during a lower pool level and seal the source of the leakage, which is likely occurring along the vertical joint between the spillway weir and right training wall;

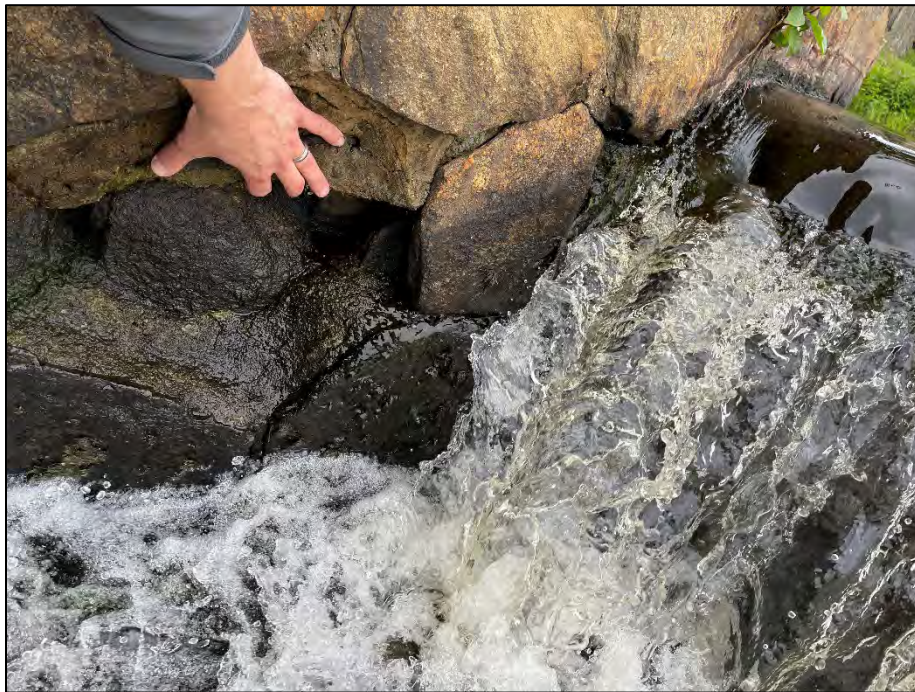
Photo No. 16.: Location of missing stone in right training wall

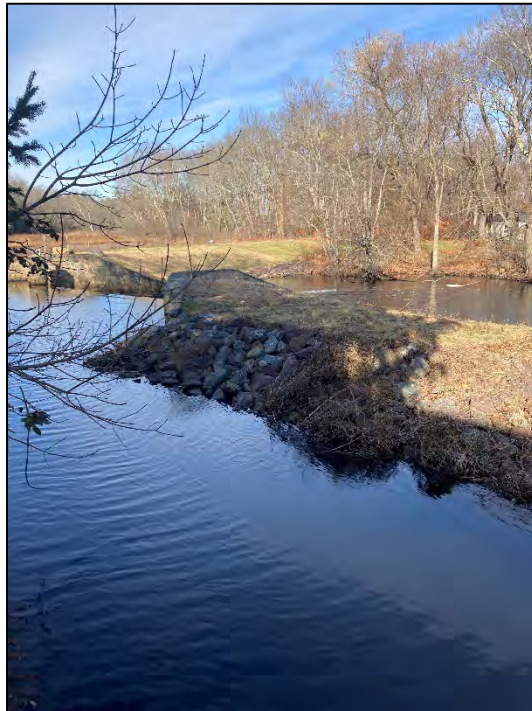
Photo No. 23.: Overview of the upstream slope between spillways and downstream slope left of the primary spillway post clearing (Provided by Town 2023-11-29).

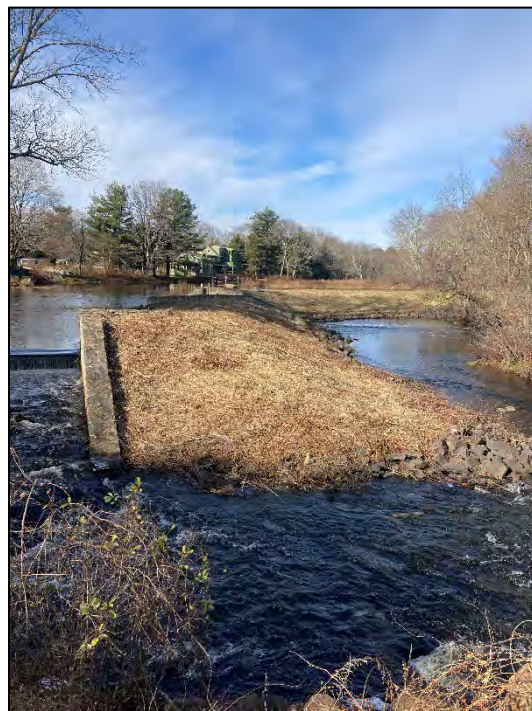
Photo No. 24.: Overview of center embankment section post clearing (Provided by Town 2023-11-29).
