The Old Manse: Historic Restoration Project – Exterior Envelope

Project Status Report & Completion Notice

10/2022

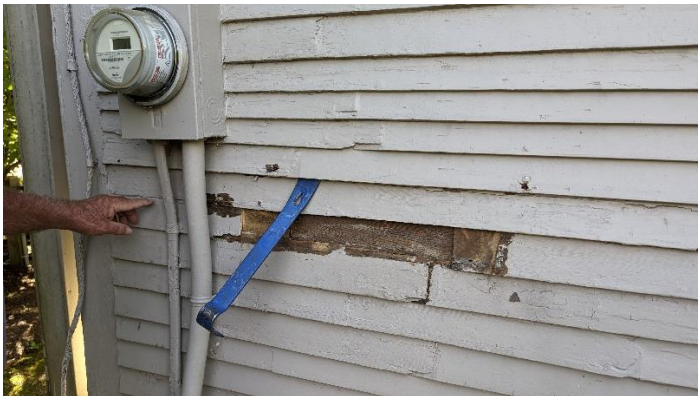
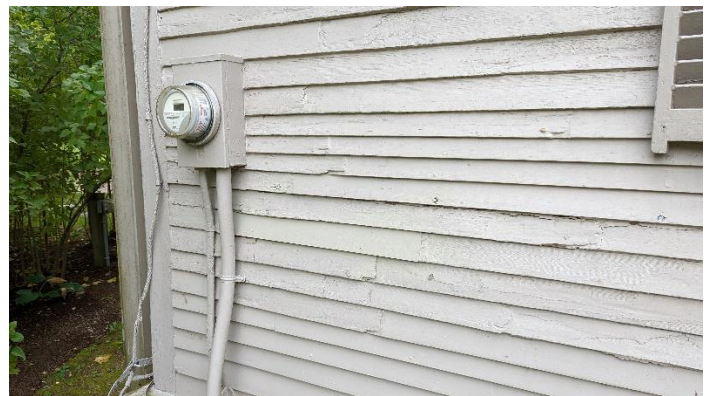
Carpentry :

Partnering with John Watson, Expert carpenter and preservationist of The Gothic Carpenter, select clapboards were identified and replaced in kind with radially quarter-sawn pine clapboards with feathered lap joints. These were primed prior to installing and secured with rose head nails.

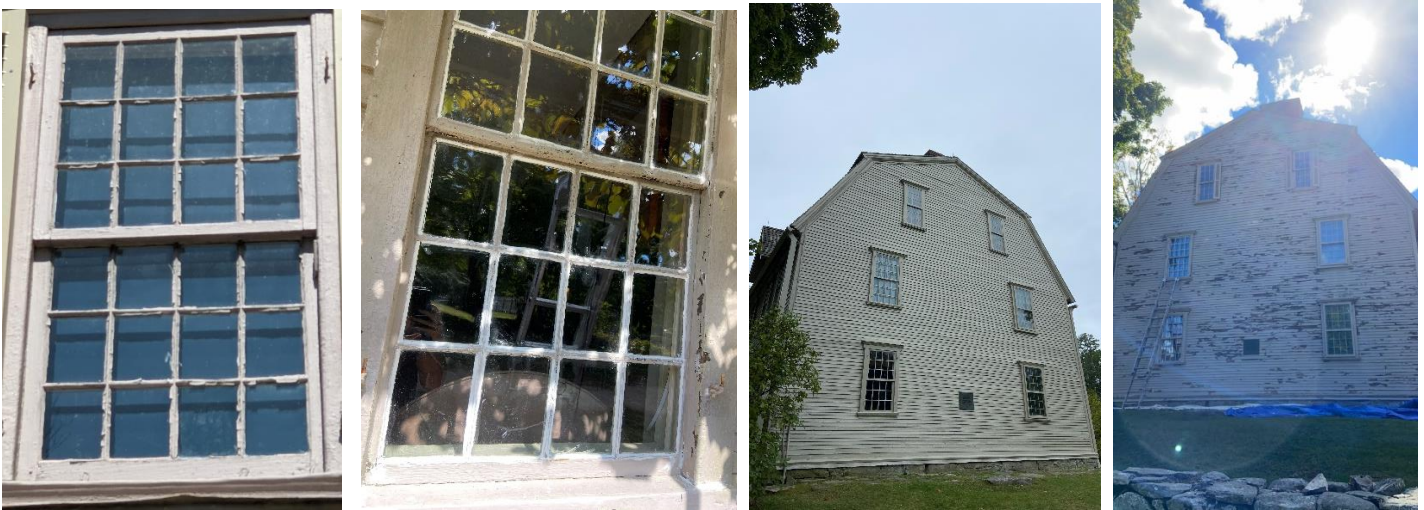
Window Glazing:

BLC Painting performed hand scraping and re-glazing on most windows, with high attention to glazing bar muntins between each single pane divided lite. Two replacement panes were installed, performed by a specialty subcontractor.
