Project/File: 179411169

Date: February 26, 2025

## Condition Study and Pavement Assessment of Forest Ridge Road, Concord, MA

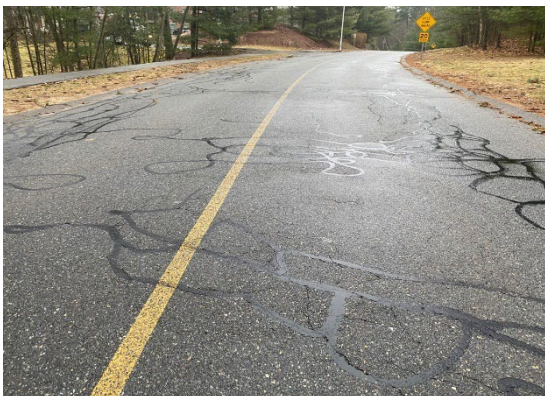
<b>PAVEMENT DISTRESS</b>	<b>SEVERITY</b>	<b>EXTENT</b>
Non-Utility Patch/Pothole	Low	0.5%
Block/Weather Cracking	Moderate	65%
Alligator Cracking	Moderate	4.0%
Transverse & Longitudinal Cracking	High	25%
Raveling/Surface Wear	Low	<75%
Distortion	Low	<1%

Pavement Condition Index (PCI) = **38**

Some pavement areas are exhibiting structural failure through localized, moderate severity alligator/fatigue cracking in the wheel path and above underground utilities within the road.

Extensive block cracking evident and due to asphalt binder aging/oxidation.

Current repair: In localized areas of fatigue cracking, cold plane existing pavement to gravel base, fine grade and compact, place 2.5" 19.0mm. Then perform curb to curb 1.5" cold planing with 1.75" overlay of 9.5mm.
