# HISTORIC STRUCTURE REPORT

## THE WRIGHT TAVERN 1747 CONCORD, MASSACHUSETTS

### Groundroot Preservation Group

**Produced for First Parish in Concord, 2014**

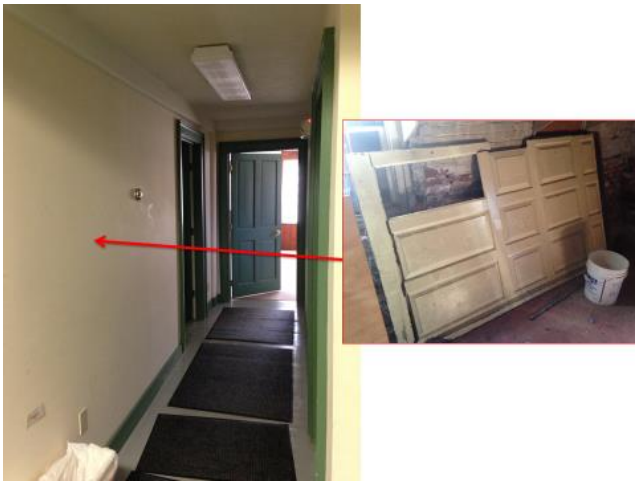
Apparently the large section of eighteenth-century, fielded paneling now stored in the basement was removed from the east wall of this space during a recent renovation. This feature may hold important clues about the changes to this space over time. If it did come from this area, it may have been left in place when rooms 102 and 103 underwent significant changes in the early nineteenth century, and may signal that the east wall of this space was a partition between rooms 102 and 103 in their original forms. This feature may also help determine whether there originally was a chimney between rooms 102 and 103, if it can be determined that the paneling was configured around a fireplace opening.

**Figure 22: View of south hallway looking south. The fielded paneling stored in the basement may originally have been located on the east wall of 100c.**

We recommend that the remaining original details remain undisturbed (i.e. the girt casings along the ceiling on the north, east and south walls) in any future work on this space, and that re-mounting the section of

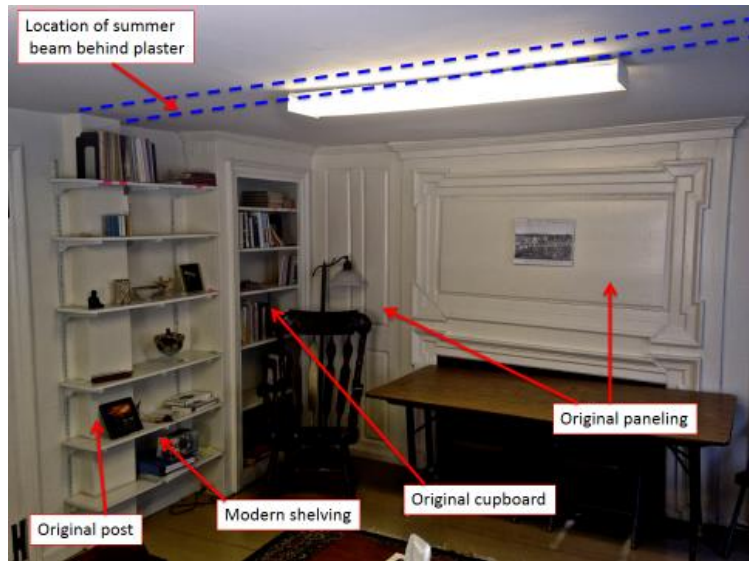
The ceiling plaster is not original; a hard gypsum material, it dates to the early twentieth century. The post at the center of the south wall exhibits a plain wooden casing with no decorative moldings, and the surface of the boards feels hand-planed. Also, the soffit and cornice above the fireplace have been adjusted to follow the slope of the ceiling. All of this suggests that this room underwent a significant repair to the ceiling in the early twentieth century, which involved dropping the ceiling to a point about four or five inches lower than it was originally. This concealed the summer beam and girts. The fireplace wall crown moldings were moved down so they would remain in view, and were adjusted to the slope of the ceiling.

Prior to the major renovation of the meeting house, ministers' offices were moved into the Wright Tavern. A closet was installed in the east end of the south wall. It utilizes commercially available, wooden, bi-fold doors and custom moldings that loosely relate to original trim elements in the building. Also, a system of bookshelves was added to the west of the south door, consisting of vertical metal tracks with adjustable brackets to support melamine shelves.

**Figure 23: View of Room 101 outlining original details and later changes.**

Today the room is in generally sound, stable condition. The noteworthy things to watch involve the floor and fireplace. This floor is very uneven, having a significant crown toward the center and a dramatic downward slope toward the fireplace. Likewise, the hearth and fire floor slope inward or to the west, dropping by as much as six inches from front to back. This indicates major settling in the chimney footing that probably occurred before the early twentieth century, and may be the reason the chimney base was stabilized with steel chains and concrete in the 1920s.<sup>22</sup>

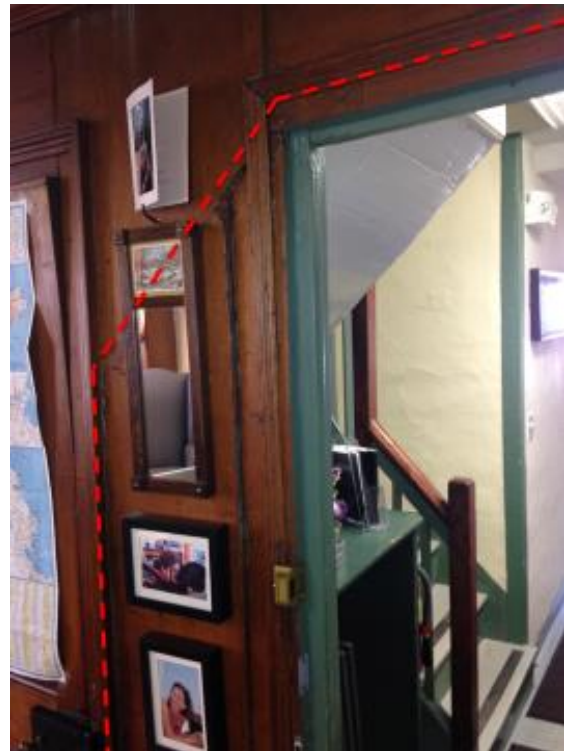
woodwork around this door also shows important change. At the time of first construction, this was all open into the stairwell (100b), as evidenced by the angled wainscot board that follows the line of the upper run of stairs. It was filled in later with another board and a door frame molding that does not match the original door moldings in the room.

**Figure 29: West wall of Room 104 showing alterations to woodwork to enclose what had originally been an open passage to 100b.**

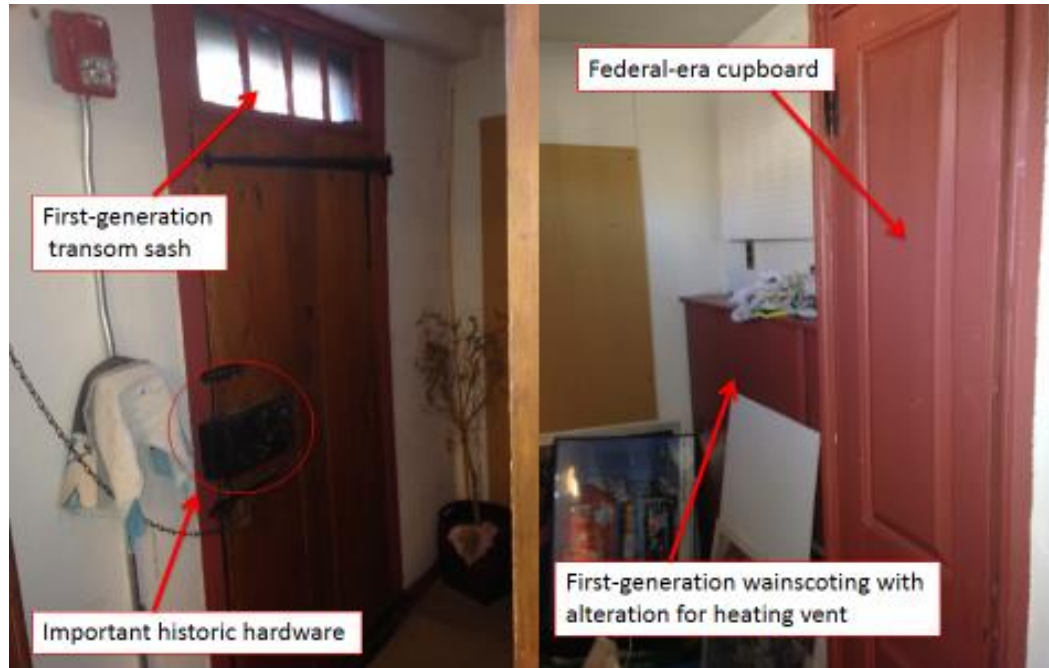
Original floorboards run north to south. There is a large, in-kind patch in front of the door, an early twentieth-century repair.

**Figure 30: Room 107 architectural details.**  
**Left: North wall showing original details.**  
**Right: South wall showing original details and later alterations.**

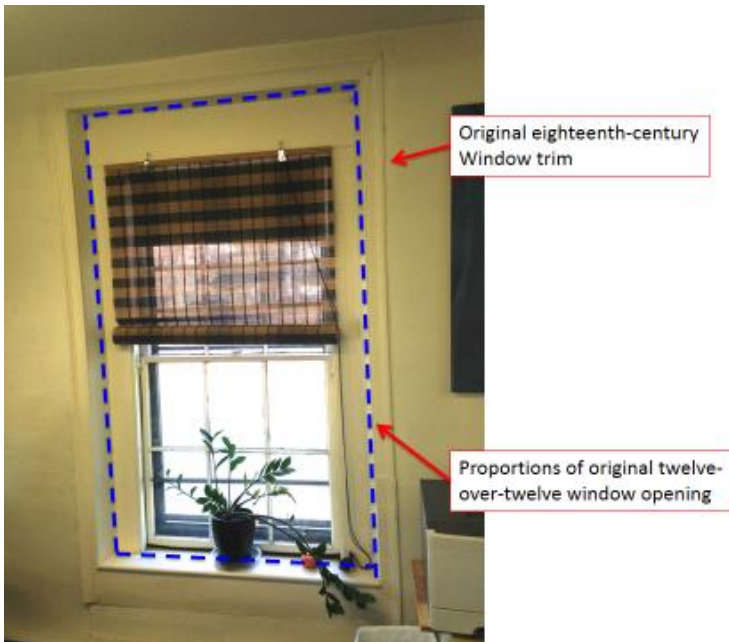
The two front windows (north wall) retain their original ogee-molded trims, and their size indicates that the first-generation windows were much larger than the current sashes, which when installed, involved reducing the openings from the inside.

**Figure 35: Window on north wall of Room 109 showing eighteenth-century trim with opening reduced inside for later sashes.**

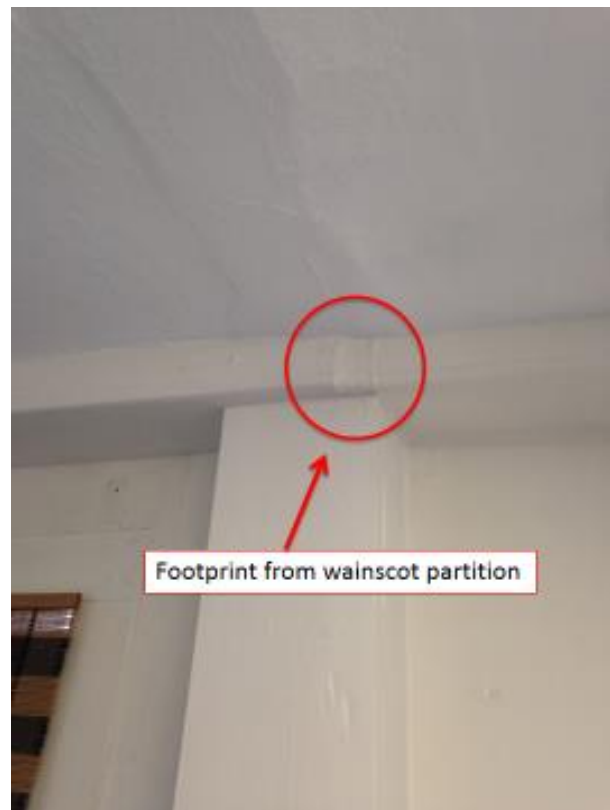
There is an infill in the ceiling plaster and in the wooden girt casing on the west wall indicating the location of a former east-west wall partition. The narrow opening in the girt casing suggests this was a wooden wainscot wall consisting merely of vertical wooden boards, rather than being a framed wall.

**Figure 36: Room 109, intersection of the west wall girt and post showing evidence of an earlier wainscot wall partition.**

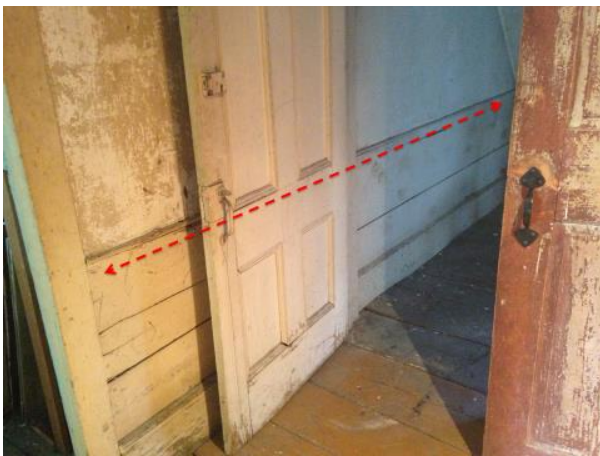
**Figure 43: Continuous dado on south wall of 300a, passing behind a later wall partition, showing that 300b and 305 were originally a single space.**

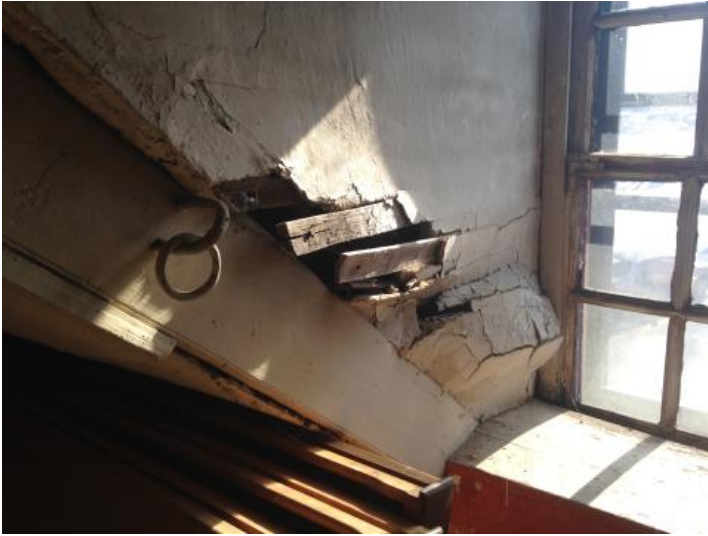
The dormers on the east facade, particularly the northern one, show signs of downward deflection and possible structural problems, indicated by buckling of plaster on the interior walls. The southern dormer on the east elevation has a similar problem, but not as severe. The structural elements of the dormers should be thoroughly inspected during dormer-related repairs made as part of roof replacement. (See Figure 46.)

There is major plaster failure on the dormer cheeks, the west wall, the north ceiling and slope, and the knee wall. These require stabilization with acrylic adhesive.

**Figure 46: Surviving areas warrant immediate consolidation. Bulging plaster in dormer cheeks signals structural settling.**

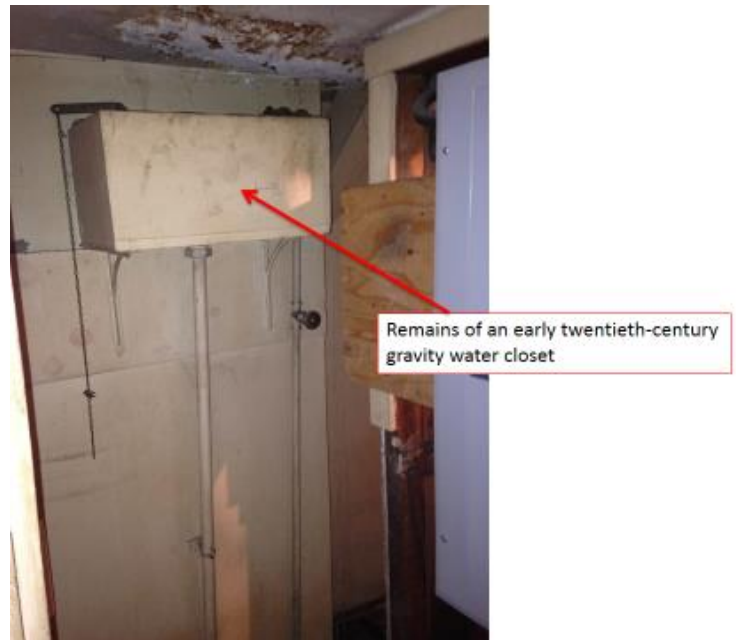
**Figure 47: The east wall of Room 303 retains elements of an early twentieth-century water closet.**

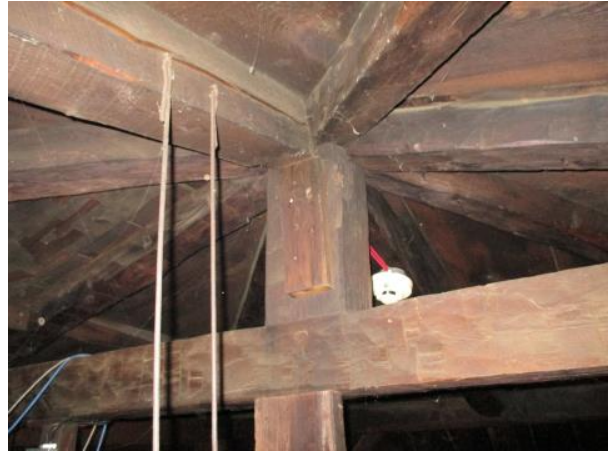
There is much original framing, including the purlin plates, sash-sawn plank joists, and hewn rafters for the upper hip radiating from the top of the king post. There have been many repairs. The original west purlin plate is rotted through and cracked across the grain. It was reinforced with a sister timber attached to it with large lag bolts in the early twentieth century. A second post was added next to the original southwest purlin post to add support to the purlin plate. The northwest joints between the purlin plates and the purlin posts have been reinforced with steel brackets installed with lag bolts. There is a recent repair to the roof framing with modern dimensional lumber and new horizontal sheathing directly above the access scuttle. The entire front (north) purlin plate was replaced in the twentieth century with a laminated beam. The northeast purlin post is also reinforced with a sister post and steel brackets.

**Figure 49: View of upper (unfinished) attic showing construction details.**

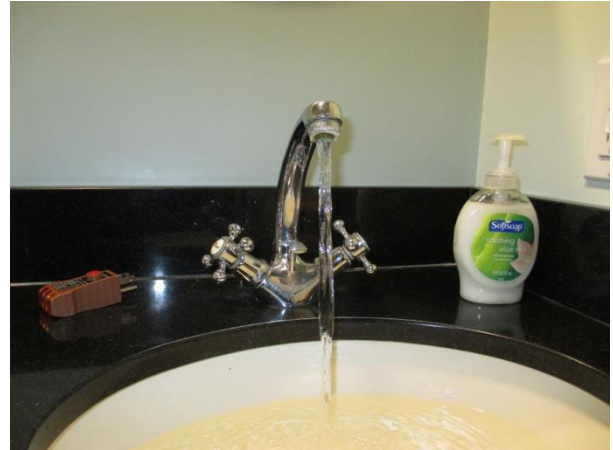
**2<sup>nd</sup>: 3 Room 206**

slightly loose. This needs to be properly secured, (2<sup>nd</sup>: 3).

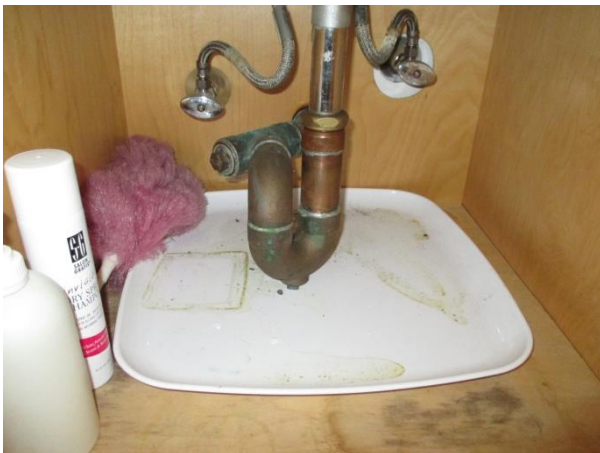
**2<sup>nd</sup>: 2 Room 206**

66. The left side bathroom sink on the second floor is serviced by a copper P-trap in its drain line configuration. While no active leak was noted at the time of inspection, both dried moisture stains and a shallow catch pan indicate the likelihood of leakage issues with this fixture in the past. This drain line should be monitored and may need to be repaired, (2<sup>nd</sup>: 2).

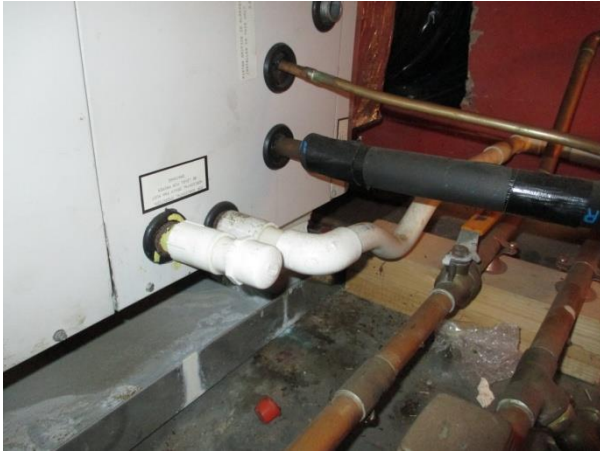
3rd: 6 Detail of southeast air handler

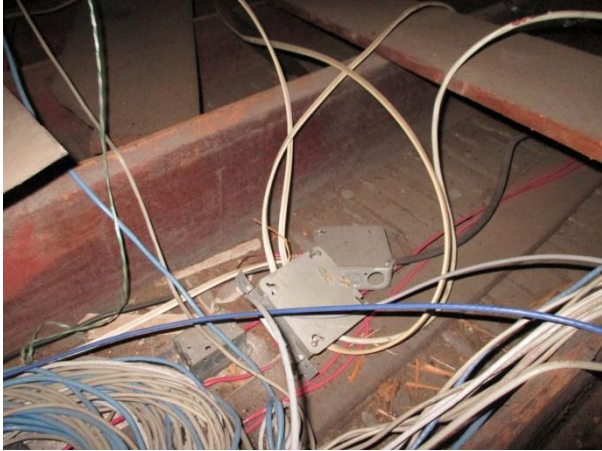
**Attic: 1 Unsecured wiring west side.**

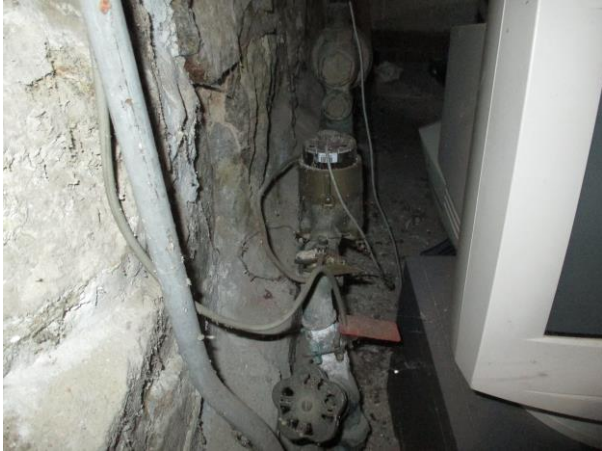
**BAS: 1** Water line and ground wire, west wall.

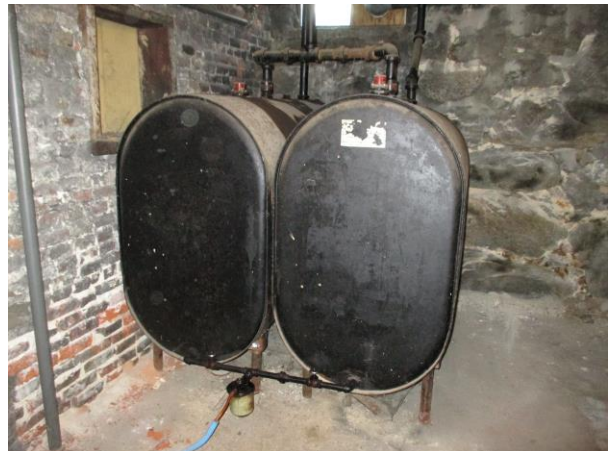
**BAS: 4** Oil tanks on north wall

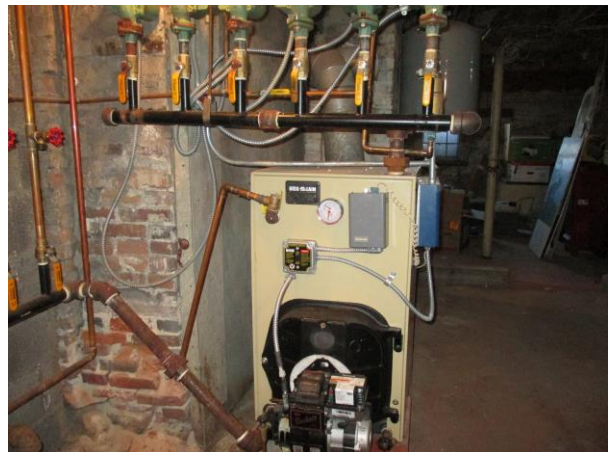
**BAS: 5** Boiler in center of basement

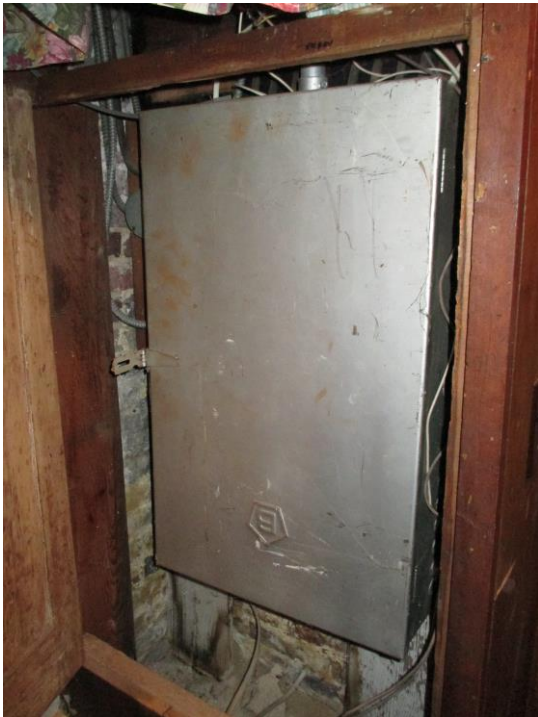
**BAS: 11 Junction box in south room.**

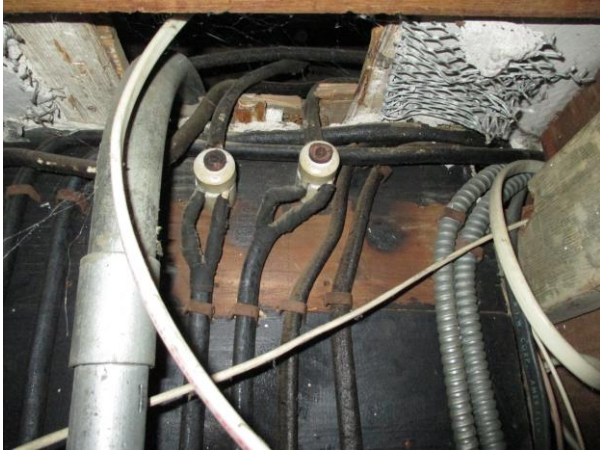
**BAS: 14 Knob and tube wiring south room**
