**NATIONAL REGISTER OF HISTORIC PLACES
INVENTORY -- NOMINATION FORM**

Massachusetts State Reformatory at Concord

MASSACHUSETTS
STATE
REFORMATORY
AT CONCORD

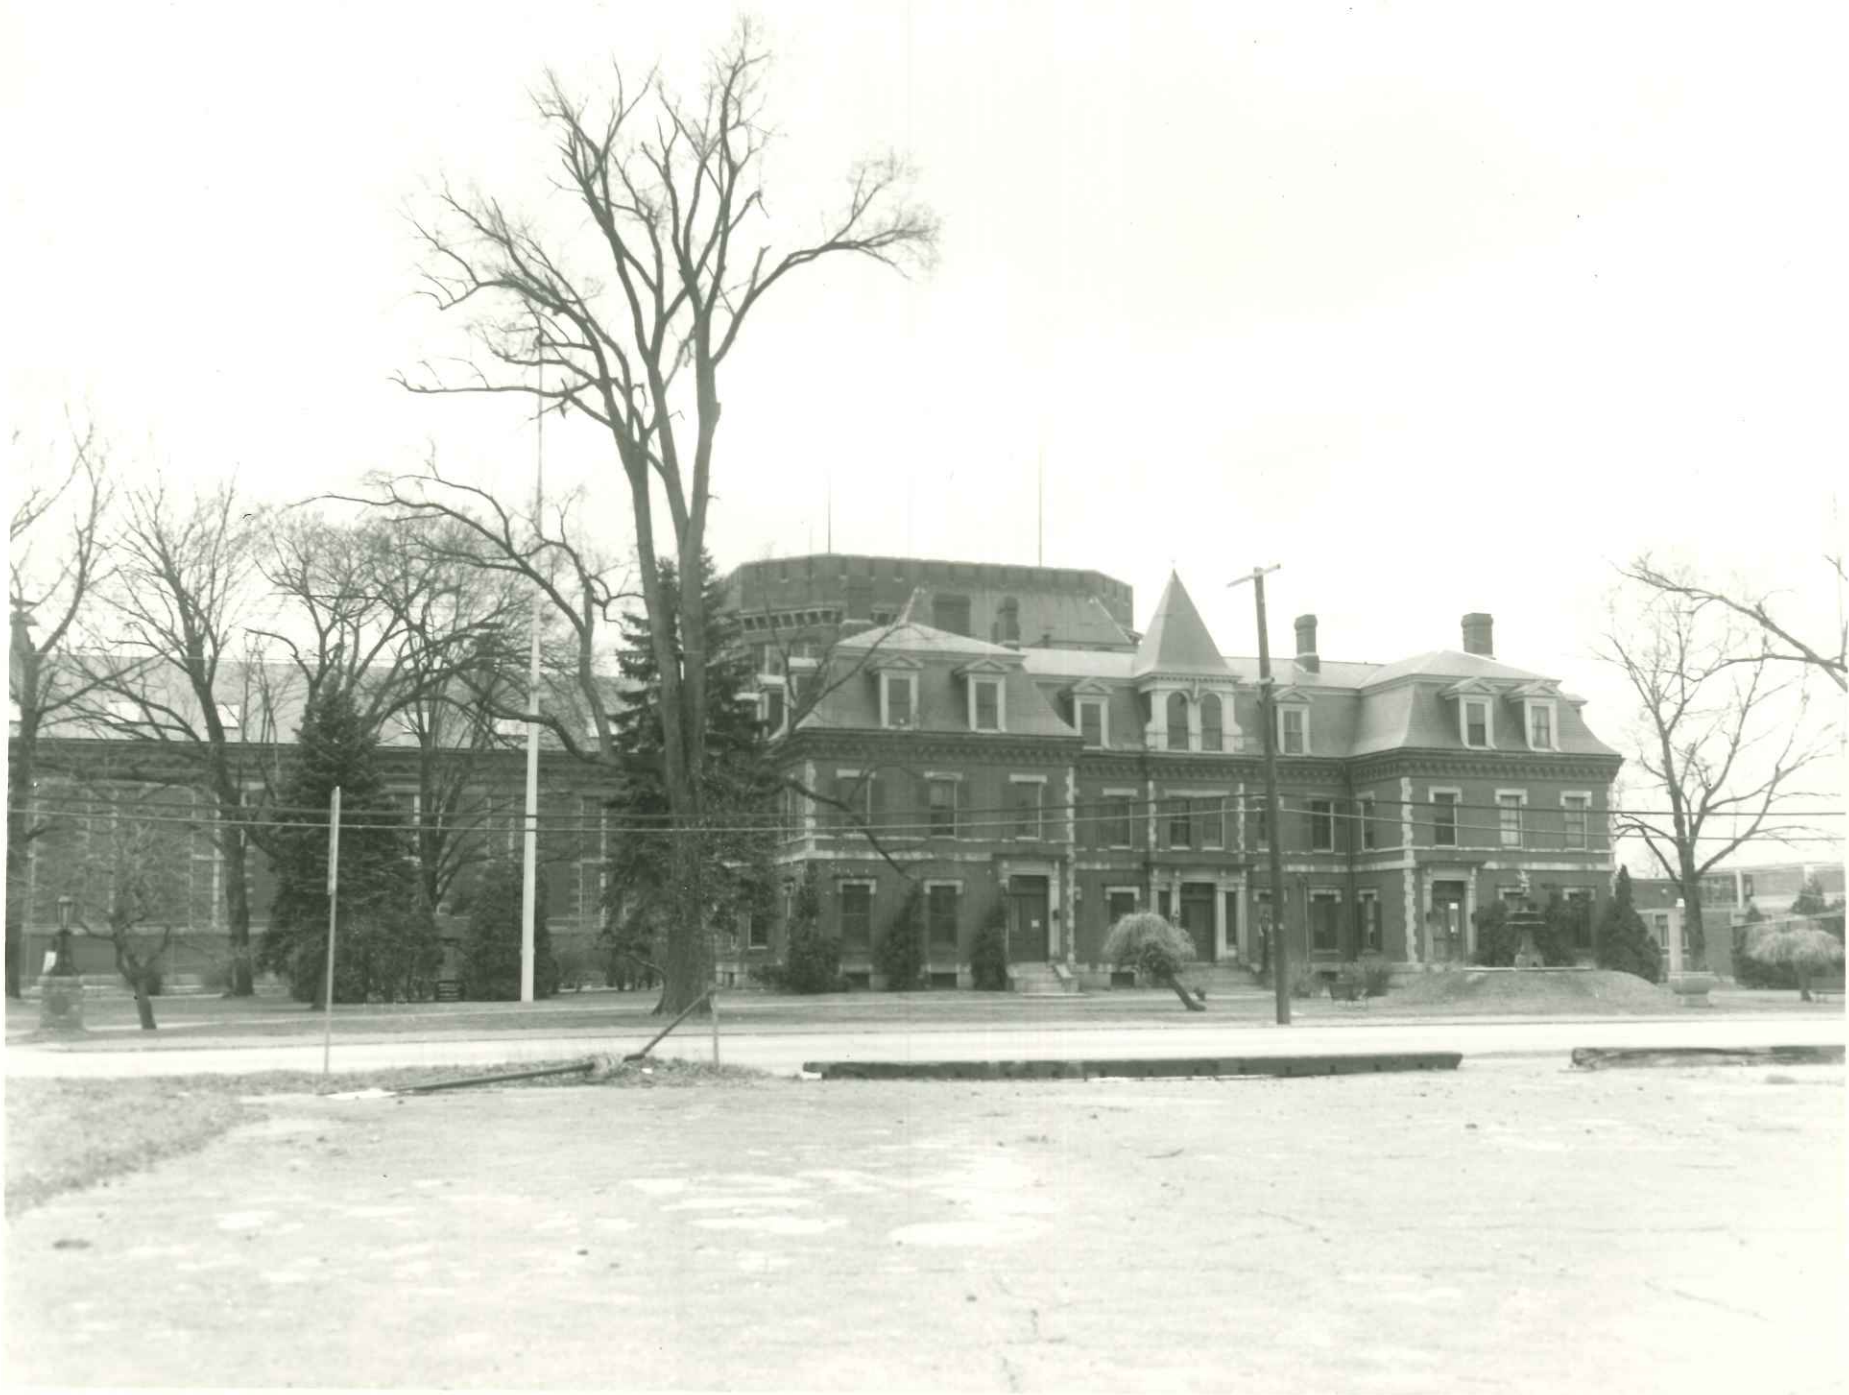
PHOTO NO. 1

1. Massachusetts State Reformatory at Concord. Front elevation looking south, showing administration building, with Warden's and Deputy Warden's residences (1 on sketch map). Original east wing to left and modern replacement of west wing to right.

Front elevation looking south, showing administration building, with Warden's and Deputy Warden's residences (1 on sketch map). Original east wing to left and modern replacement of west wing to right.

Behind this building, is the eight-sided central building (2), which originally had, over the hospital on the top floor, a large dome and cupola, now gone. Called the "Octagon", it is really a square with the corners cut off. The main walls are of brick with the shorter corner sections filled with barred windows. Just below the crenellation at the top is a copper pent roof supported by large granite brackets. Connecting this building to the entrance is an elaborate covered carriageway (3), designed with heavy security gates at each end, for delivery of prisoners by van.

Of the two wings which originally flanked the octagon, only the east remains (4). Built of red brick with rough granite trim, it is larger in scale and simpler in detail than the entrance building, but echoes its design. The brick cornice is an expanded version of that on the entrance building. The facade is broken at regular intervals by tall barred windows with heavy granite coursing above and below, and granite quoins. These are inset between simple brick pilasters. The slate hip roof has rectangular sky lights corresponding to the windows, and three ventilators along the ridge.

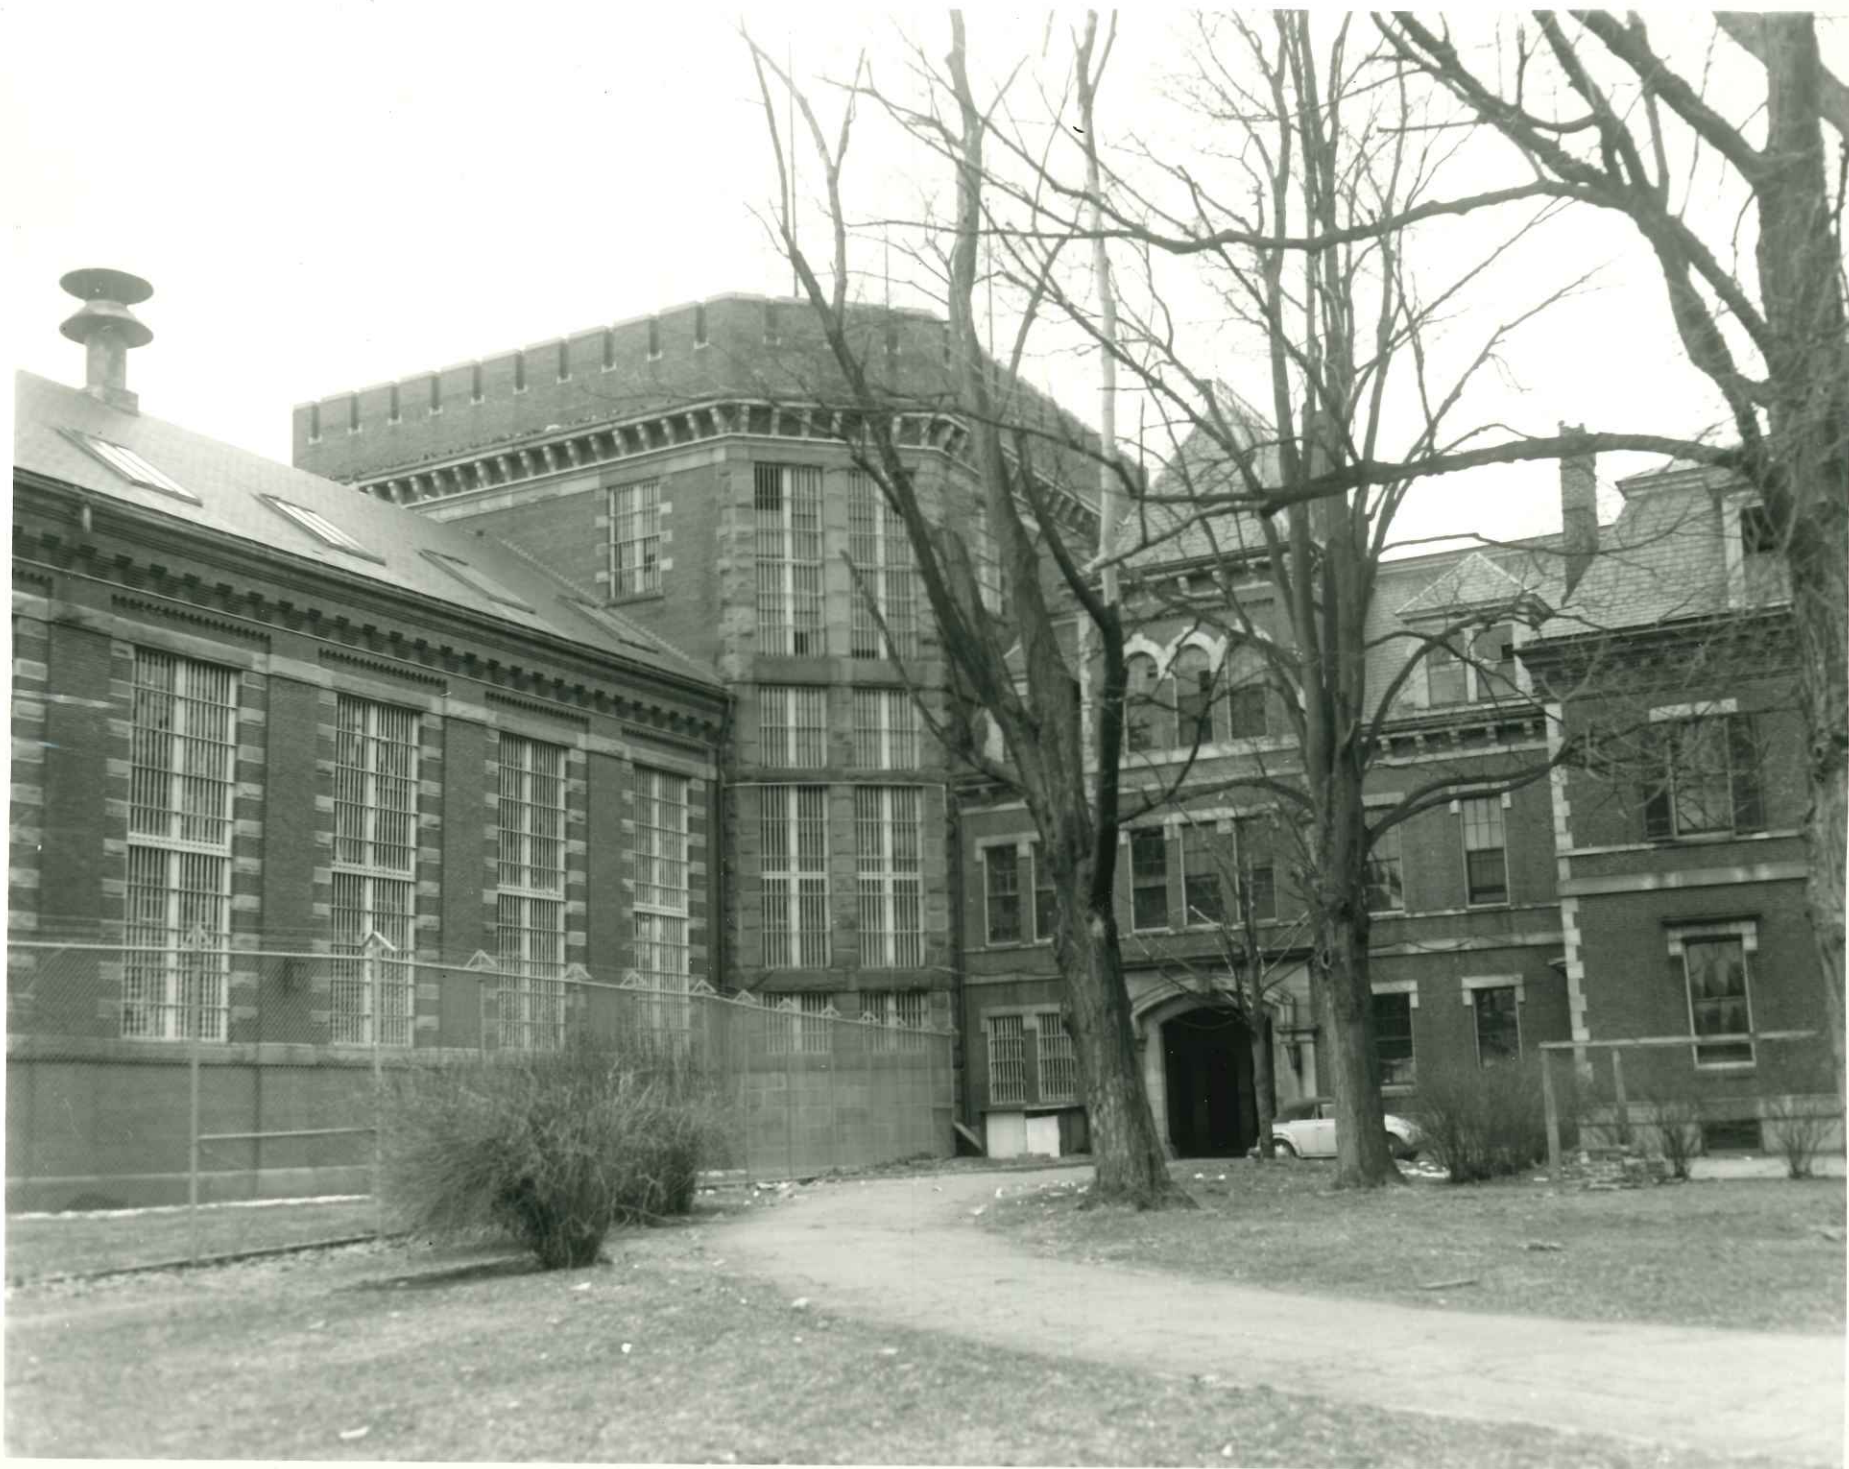
PHOTO NO. 2

2. Massachusetts Reformatory at Concord. Looking southwest showing administration building/Warden's residence (1 on sketch map) at right, carriage entrance (3 on sketch map), 'octagon' (2 on sketch map) and east wing (4 on sketch map).

Looking southwest showing administration building/Warden's residence (1 on sketch map) at right, carriage entrance (3 on sketch map), 'octagon' (2 on sketch map) and east wing (4 on sketch map).

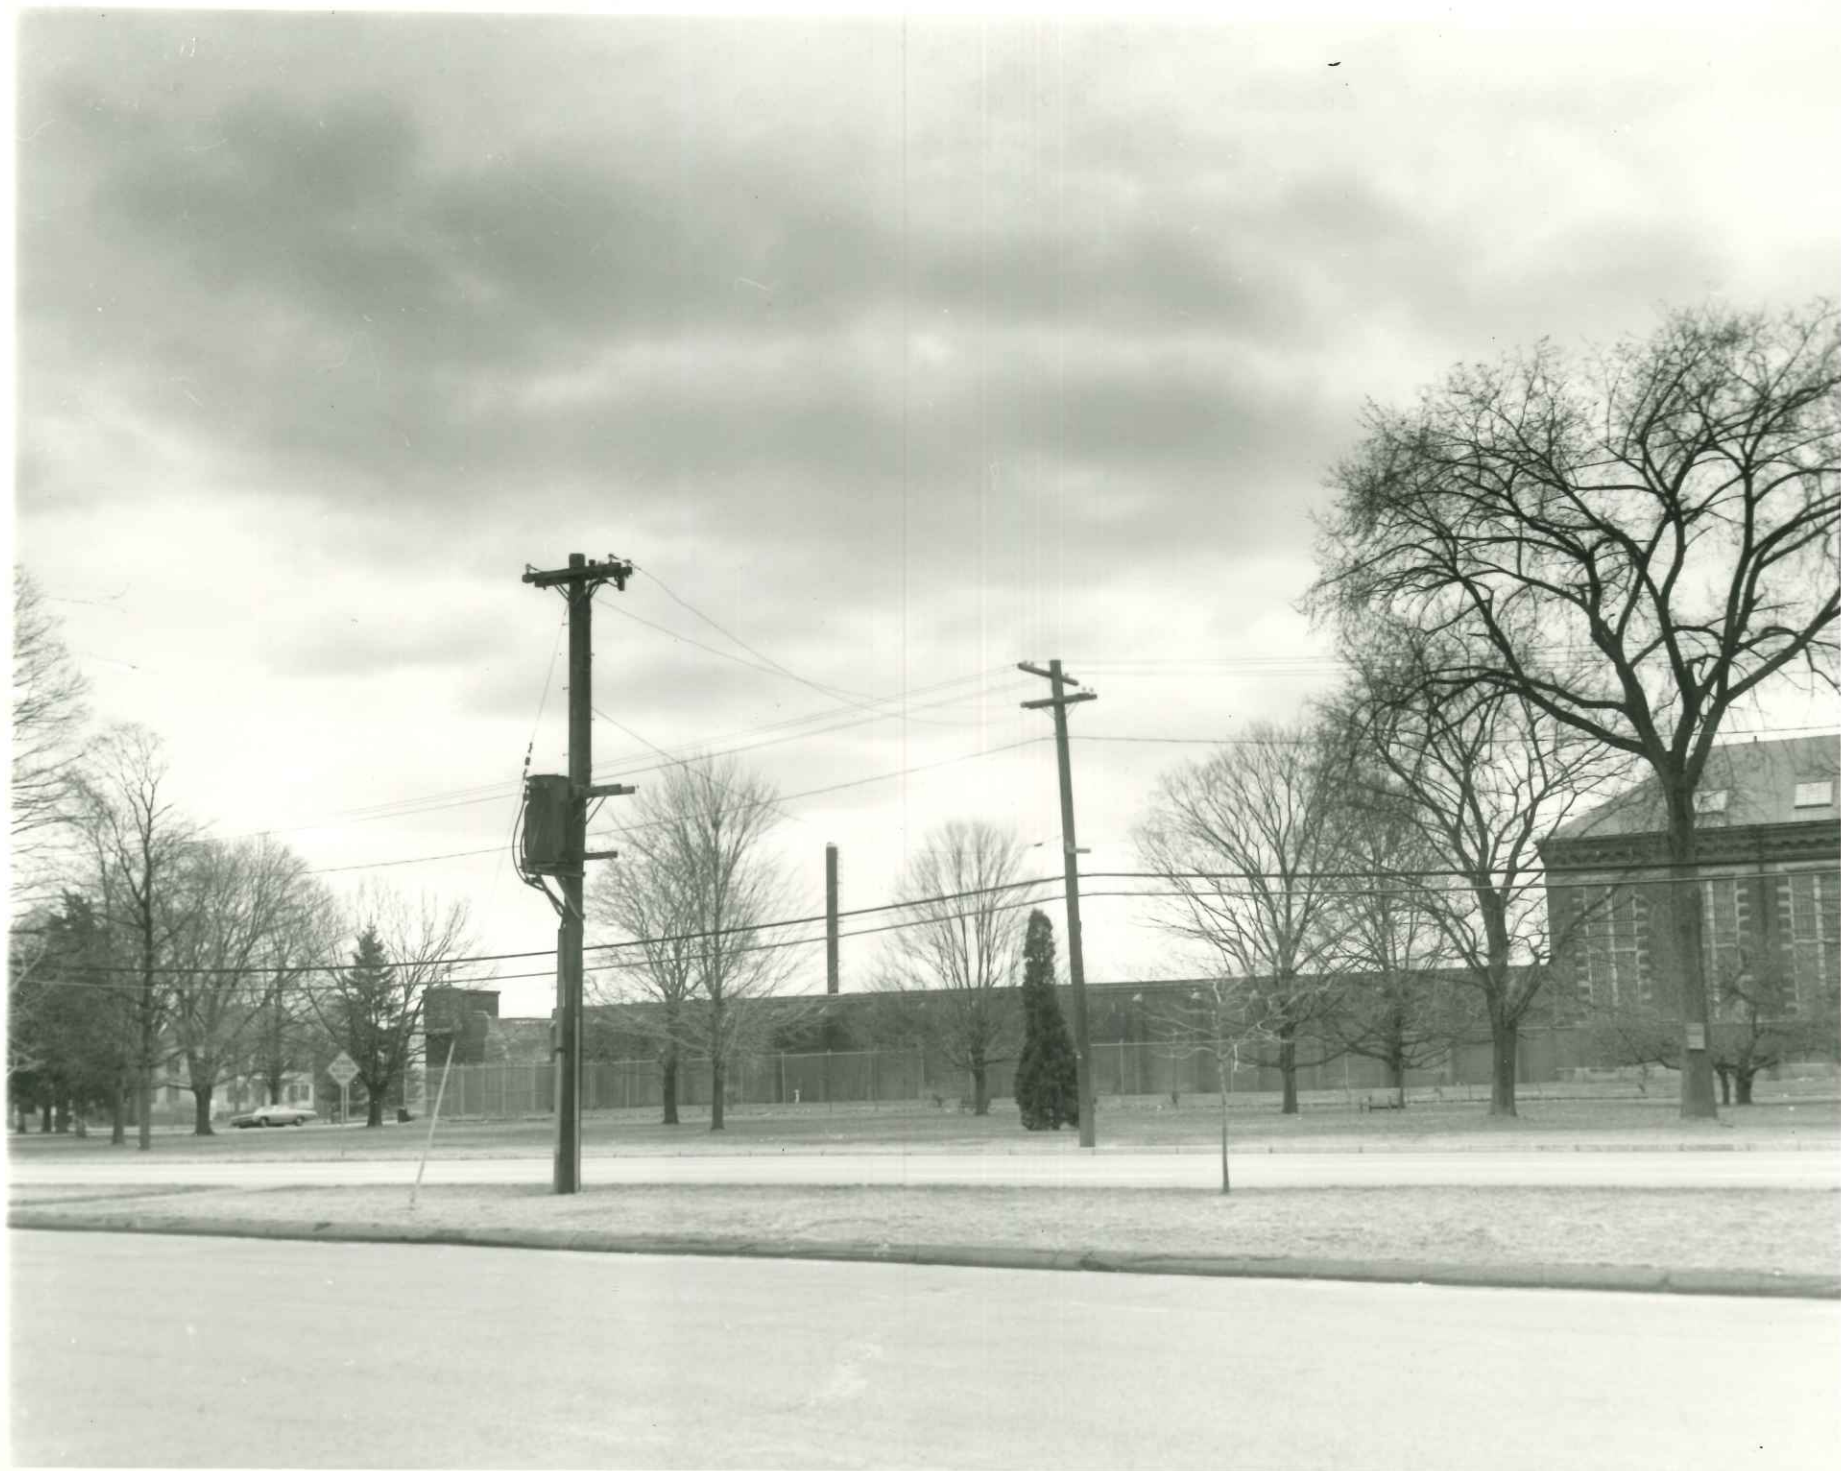
PHOTO NO. 3

3. Massachusetts State Reformatory at Concord, Looking south east, showing end of east wing (4 on sketch map,) at right, prison wall (5 on sketch map) and staff housing (7 on sketch map) at left.

Looking southeast, showing end of east wing (4 on sketch map) at right, prison wall (5 on sketch map) and staff housing (7 on sketch map) at left.

Extending from the end of the wing to surround the main compound is a high wall (5) of simple brick panels between heavy brick posts on a granite foundation. Modern guard towers have been added to this wall at several points. The whole complex is fronted by a rather formally landscaped lawn with tall trees. A curved drive with formal entrance posts defines the area in front of the entrance building, where a handsome fountain sits on a central mound, flanked by mulberry trees. Landscaping around the house is mostly evergreen, with a gazebo on the warden's side.

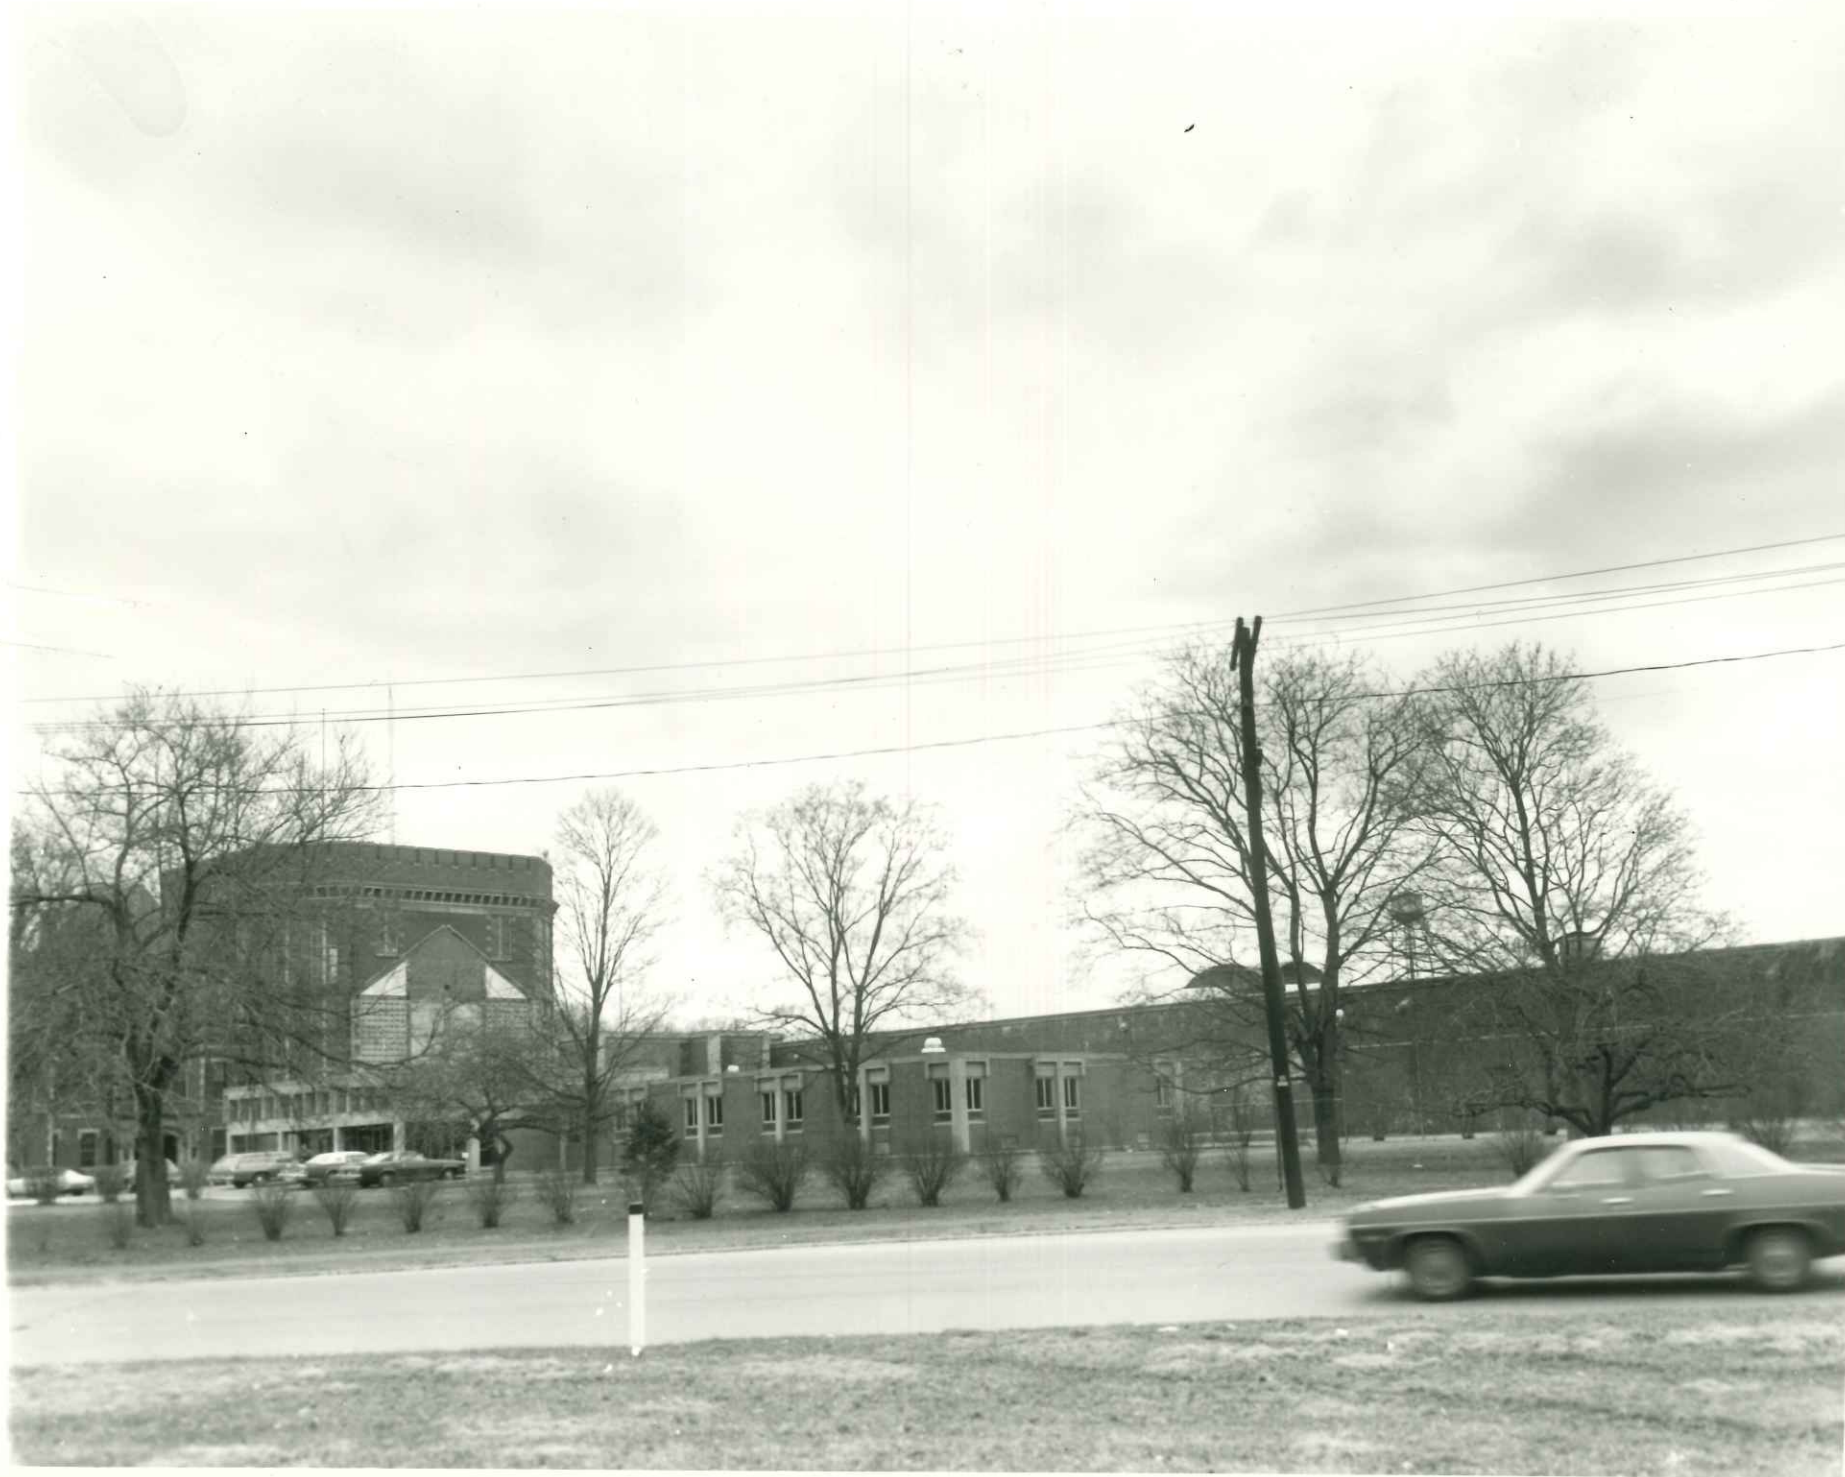
PHOTO NO. 4

4. Massachusetts State Reformatory at Concord. Looking south east showing replacement of original west wing with 'octagon' (2 on sketch map) at left and original prison wall (5 on sketch map) at right. New guard towers are visible.

Looking southeast showing replacement of original west wing with 'octagon' (2 on sketch map) at left and original prison wall (5 on sketch map) at right. New guard towers are visible.

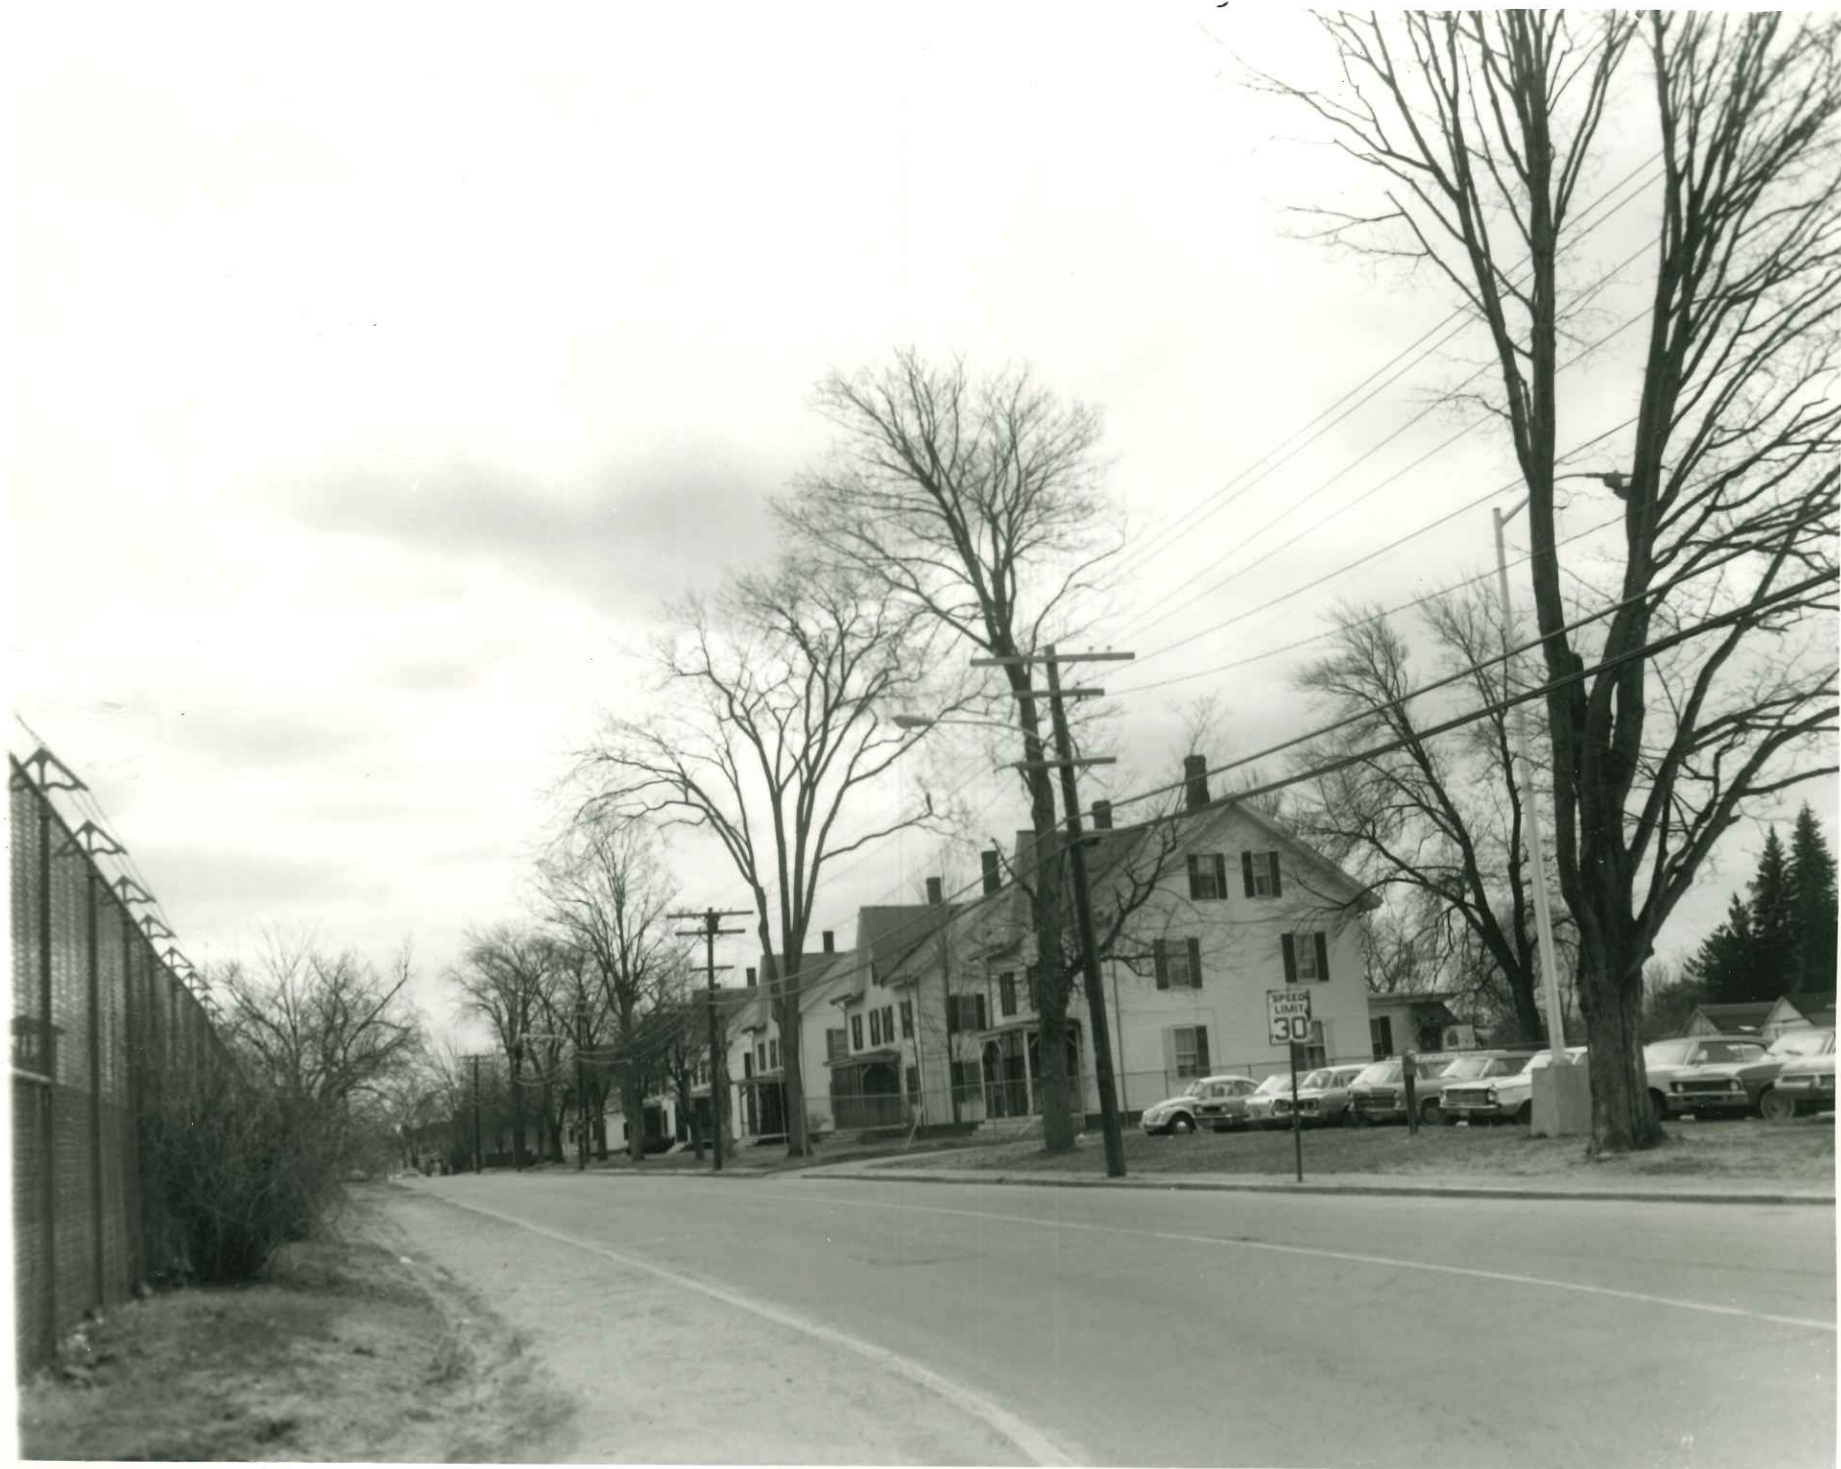
PHOTO NO. 5

5. Massachusetts State Reformatory at Concord, Looking south showing staff housing (6 on sketch map) along Commonwealth Avenue with west wall of prison to left.

Looking south showing staff housing (6 on sketch map) along Commonwealth Avenue with west wall of prison to left.

To the west of the complex is a row of seven double frame houses (6) fronting on Commonwealth Avenue, built as staff housing at the time the prison was built. These are very utilitarian, symmetrical 2-story houses with clapboard siding and plain stick-style entrance porches. To the east are three more staff houses (7) built in 1884, when the facility became a reformatory. These are similar to the earlier houses, but with heavier proportions and different entrance porches.

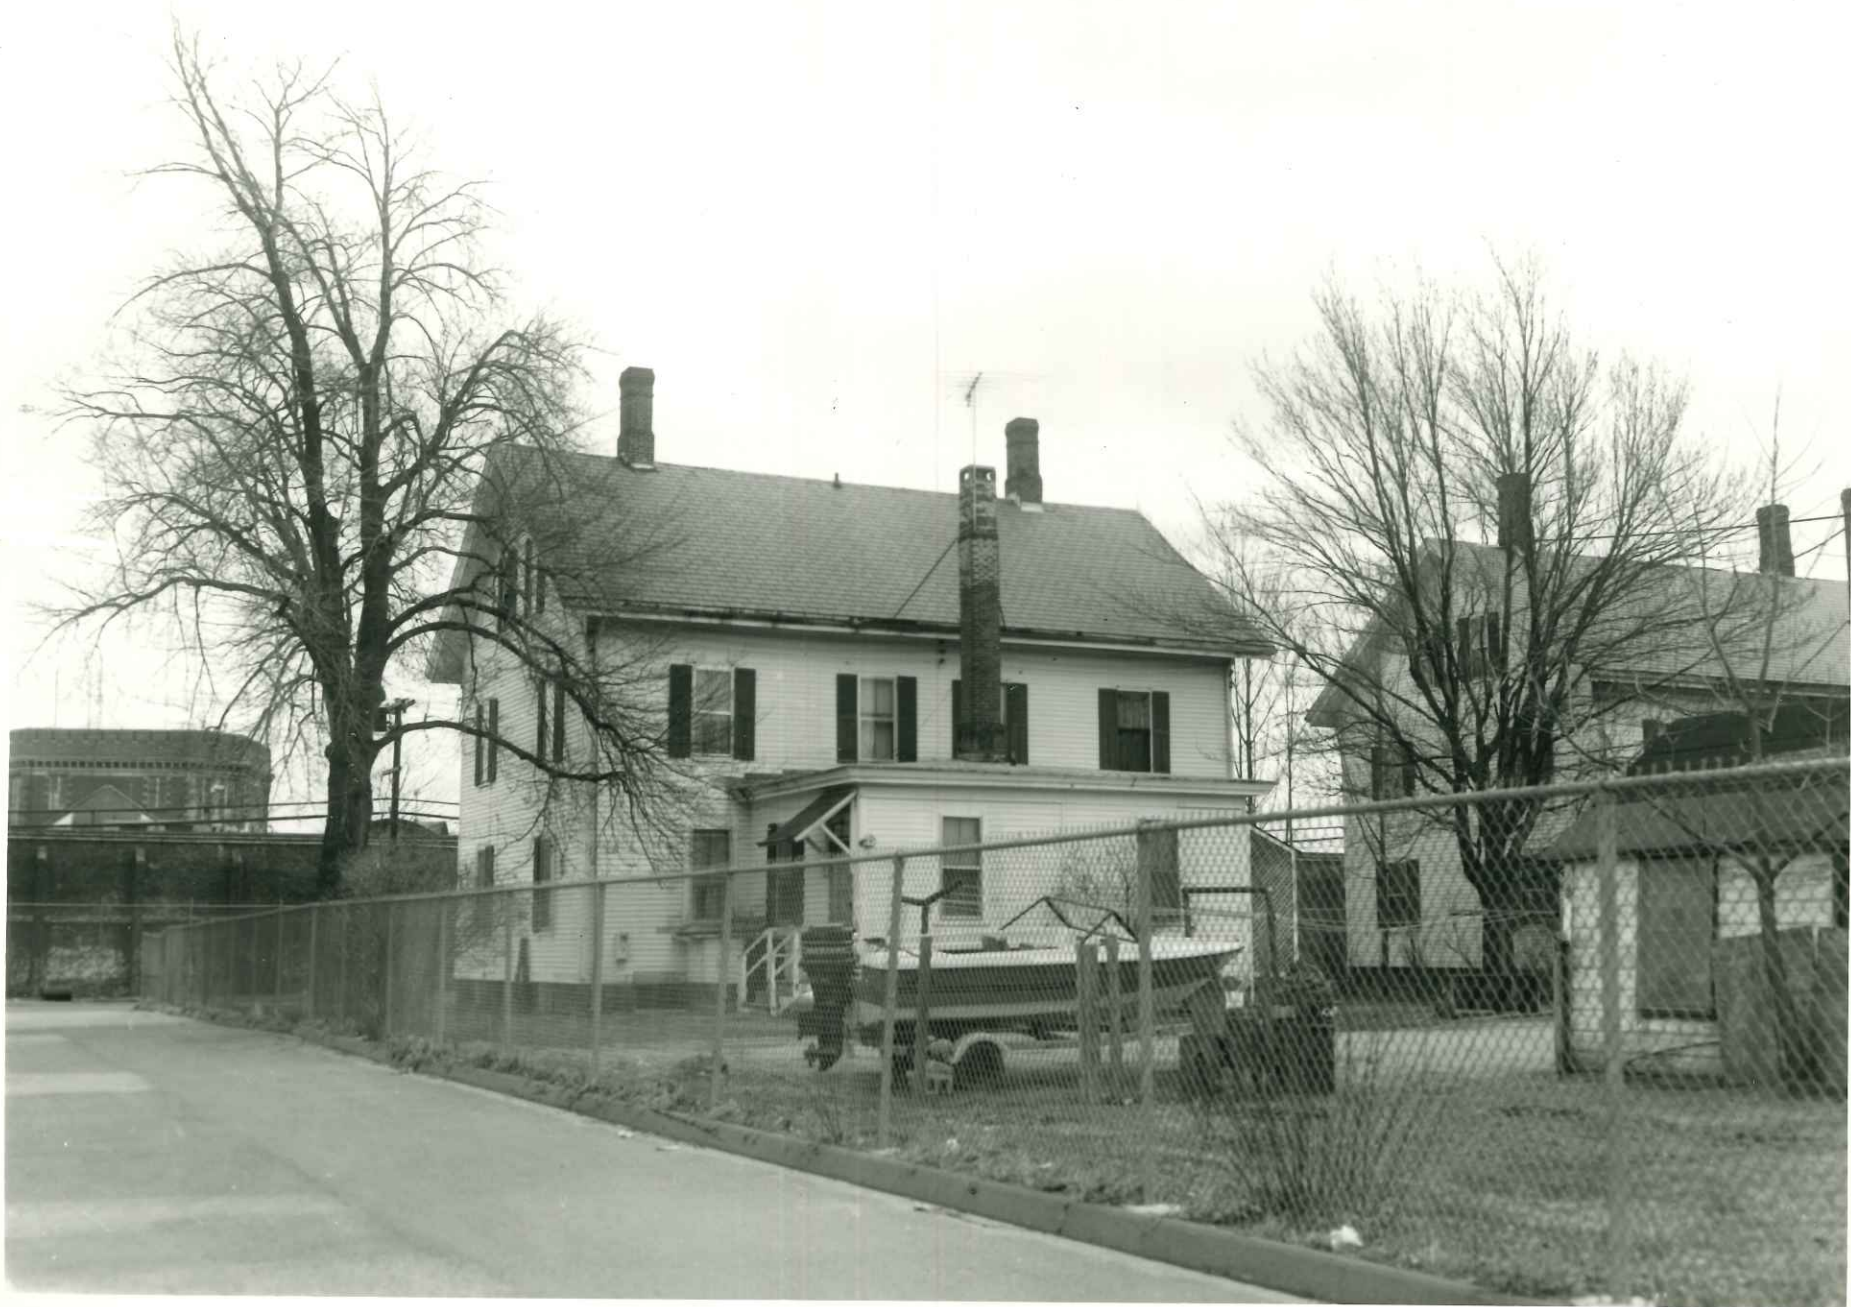
PHOTO NO. 6

Co. Massachusetts State Reformatory at Concord. Staff housing (6 on sketch map)
looking east, side and rear elevations, main prison in
background.

Staff housing (6 on sketch map) looking east, side and rear elevations, main
prison in background.

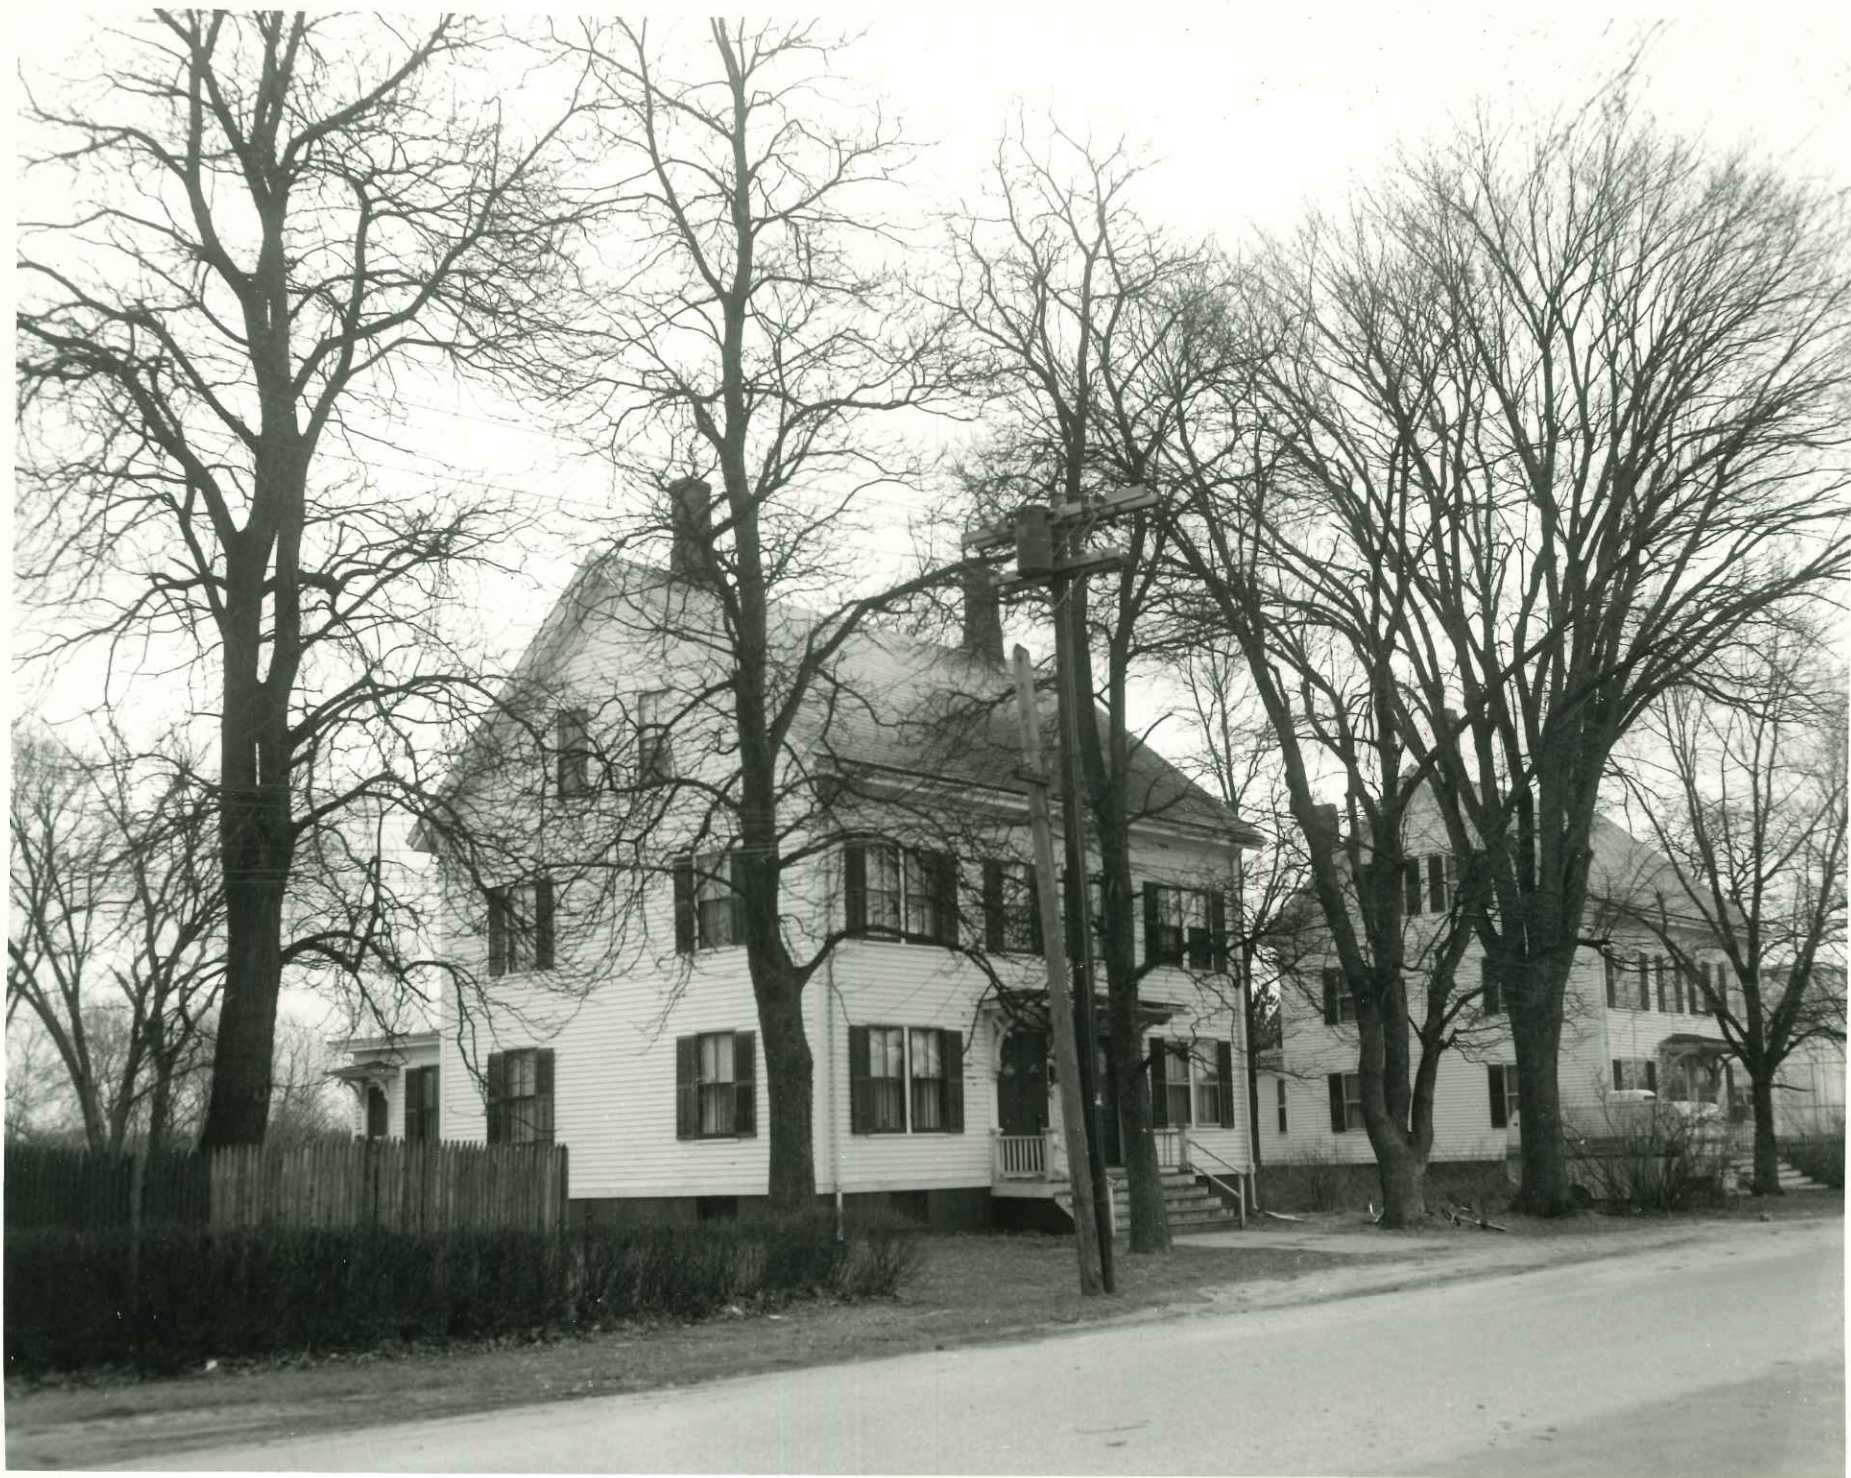
7. Massachusetts State Reformatory at Concord, staff housing (7 on sketch map) looking southeast, front and side elevations.

DESCRIBE VIEW, DIRECTION, ETC. IF DISTRICT, GIVE BUILDING NAME & STREET PHOTO NO. 7
Staff housing (7 on sketch map) looking southeast, front and side elevations.

Typically, this is a wood-frame double-house that rises 2 and 1/2 stories from a brick and stone foundation to an overhanging slate gable roof with interior stove chimneys. The house is sheathed with clapboards and trimmed with cornerboards, watertable and fascia with half-round moldings underlining the entire roof profile. Fenestration is regular, and aligned at the first and second stories; windows are trimmed with molded frames, bracketed sills, louvered shutters, and contain 2/2 double-hung sash (photo #7)

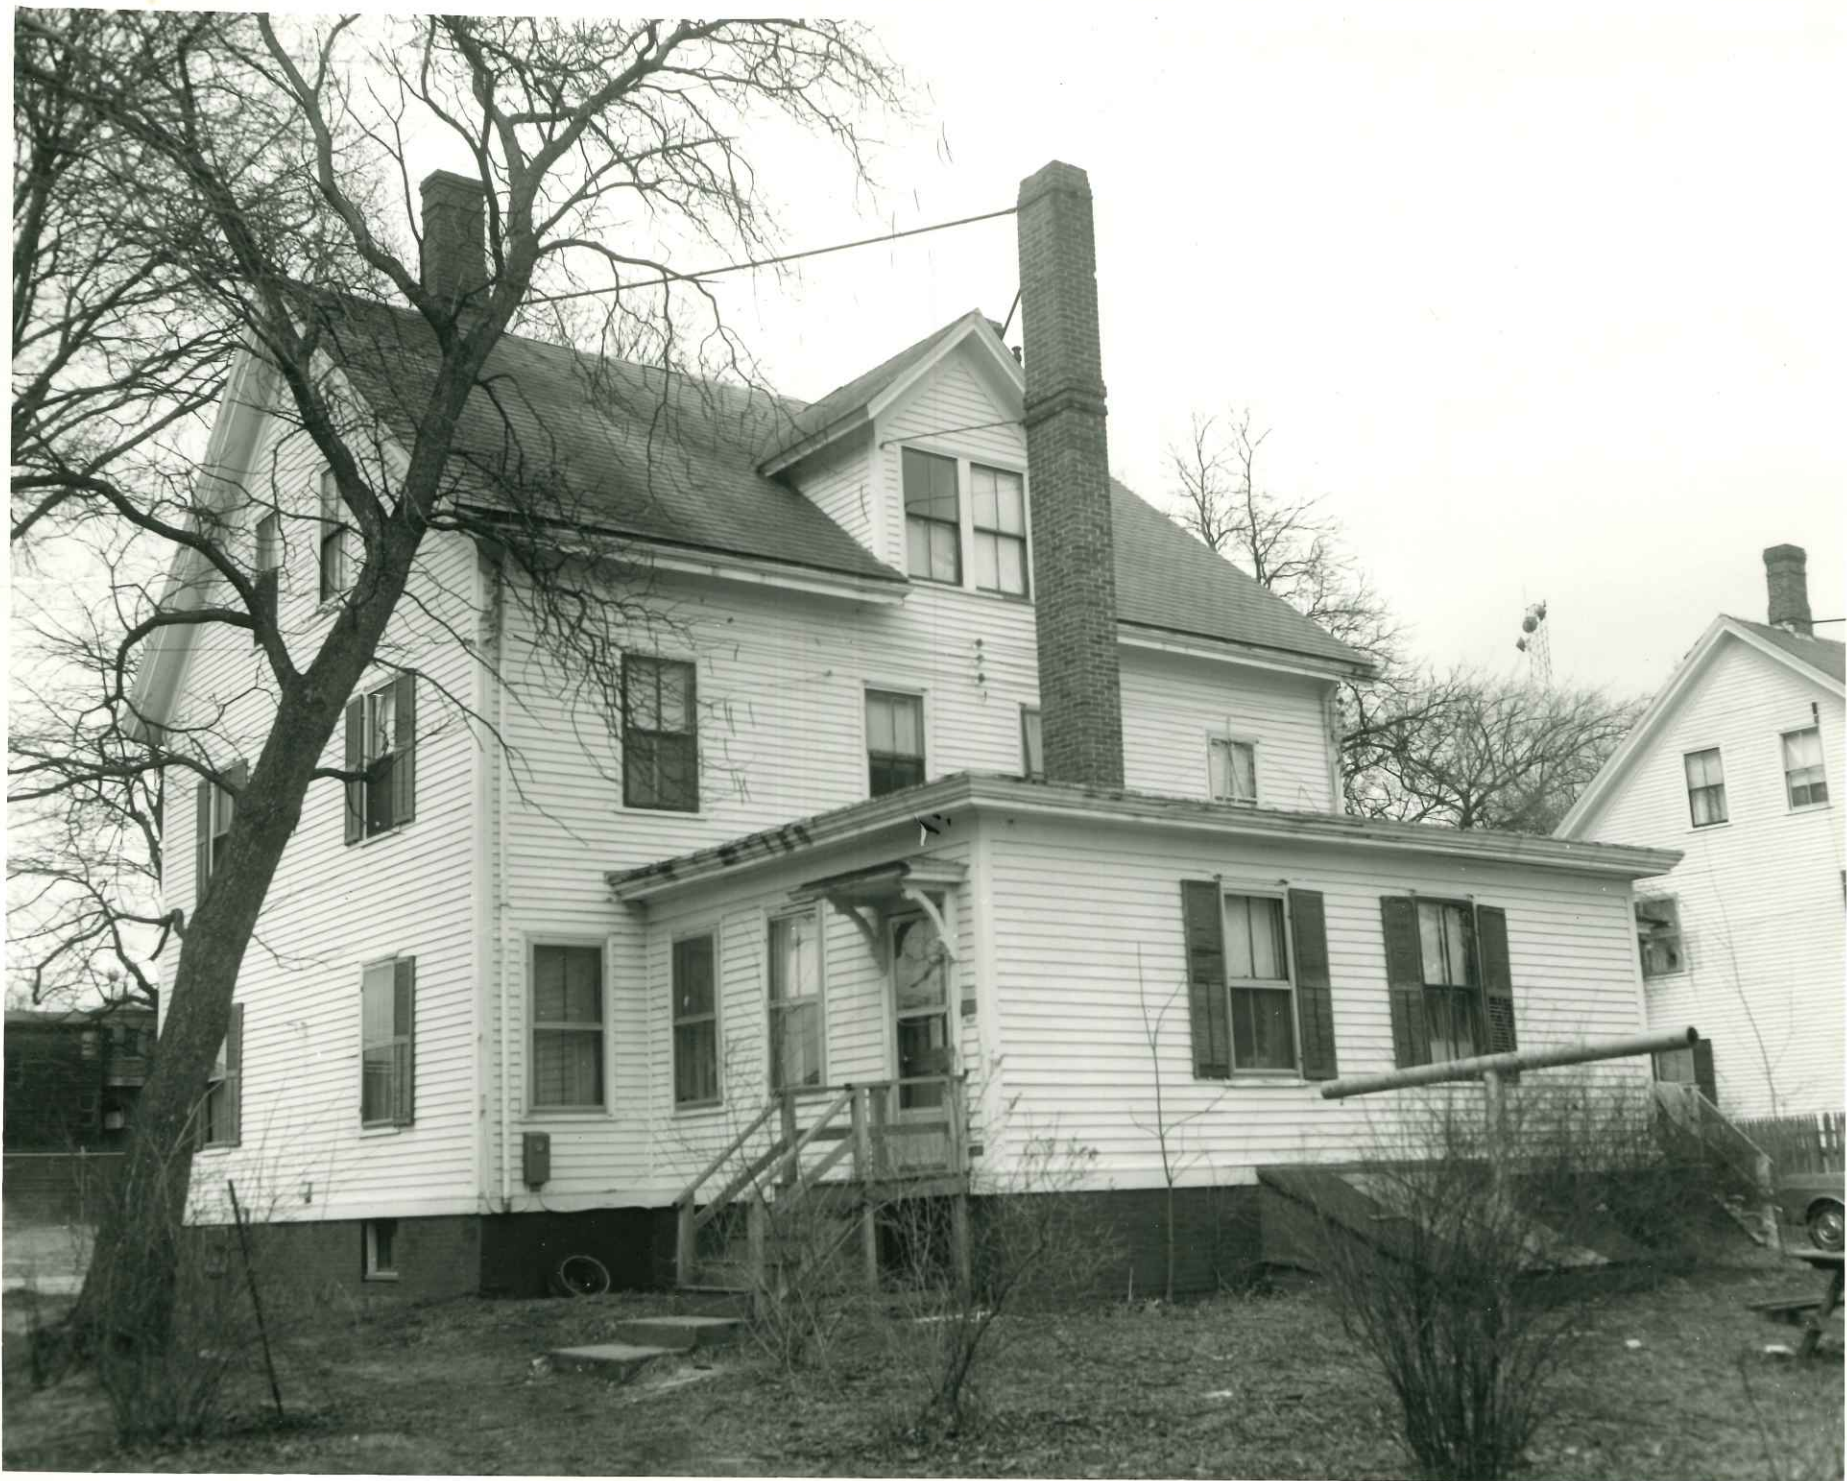
PHOTO NO. 8

8. Massachusetts State Reformatory at Concord. Staff housing
(7 on sketch map) looking west, side and rear elevations.
Prison wall in background.

Staff housing (7 on sketch map) looking west, side and rear elevations. Prison wall in background.
