**NATIONAL REGISTER OF HISTORIC PLACES
INVENTORY -- NOMINATION FORM**

Massachusetts State Reformatory at Concord

MASSACHUSETTS
STATE
REFORMATORY
AT CONCORD

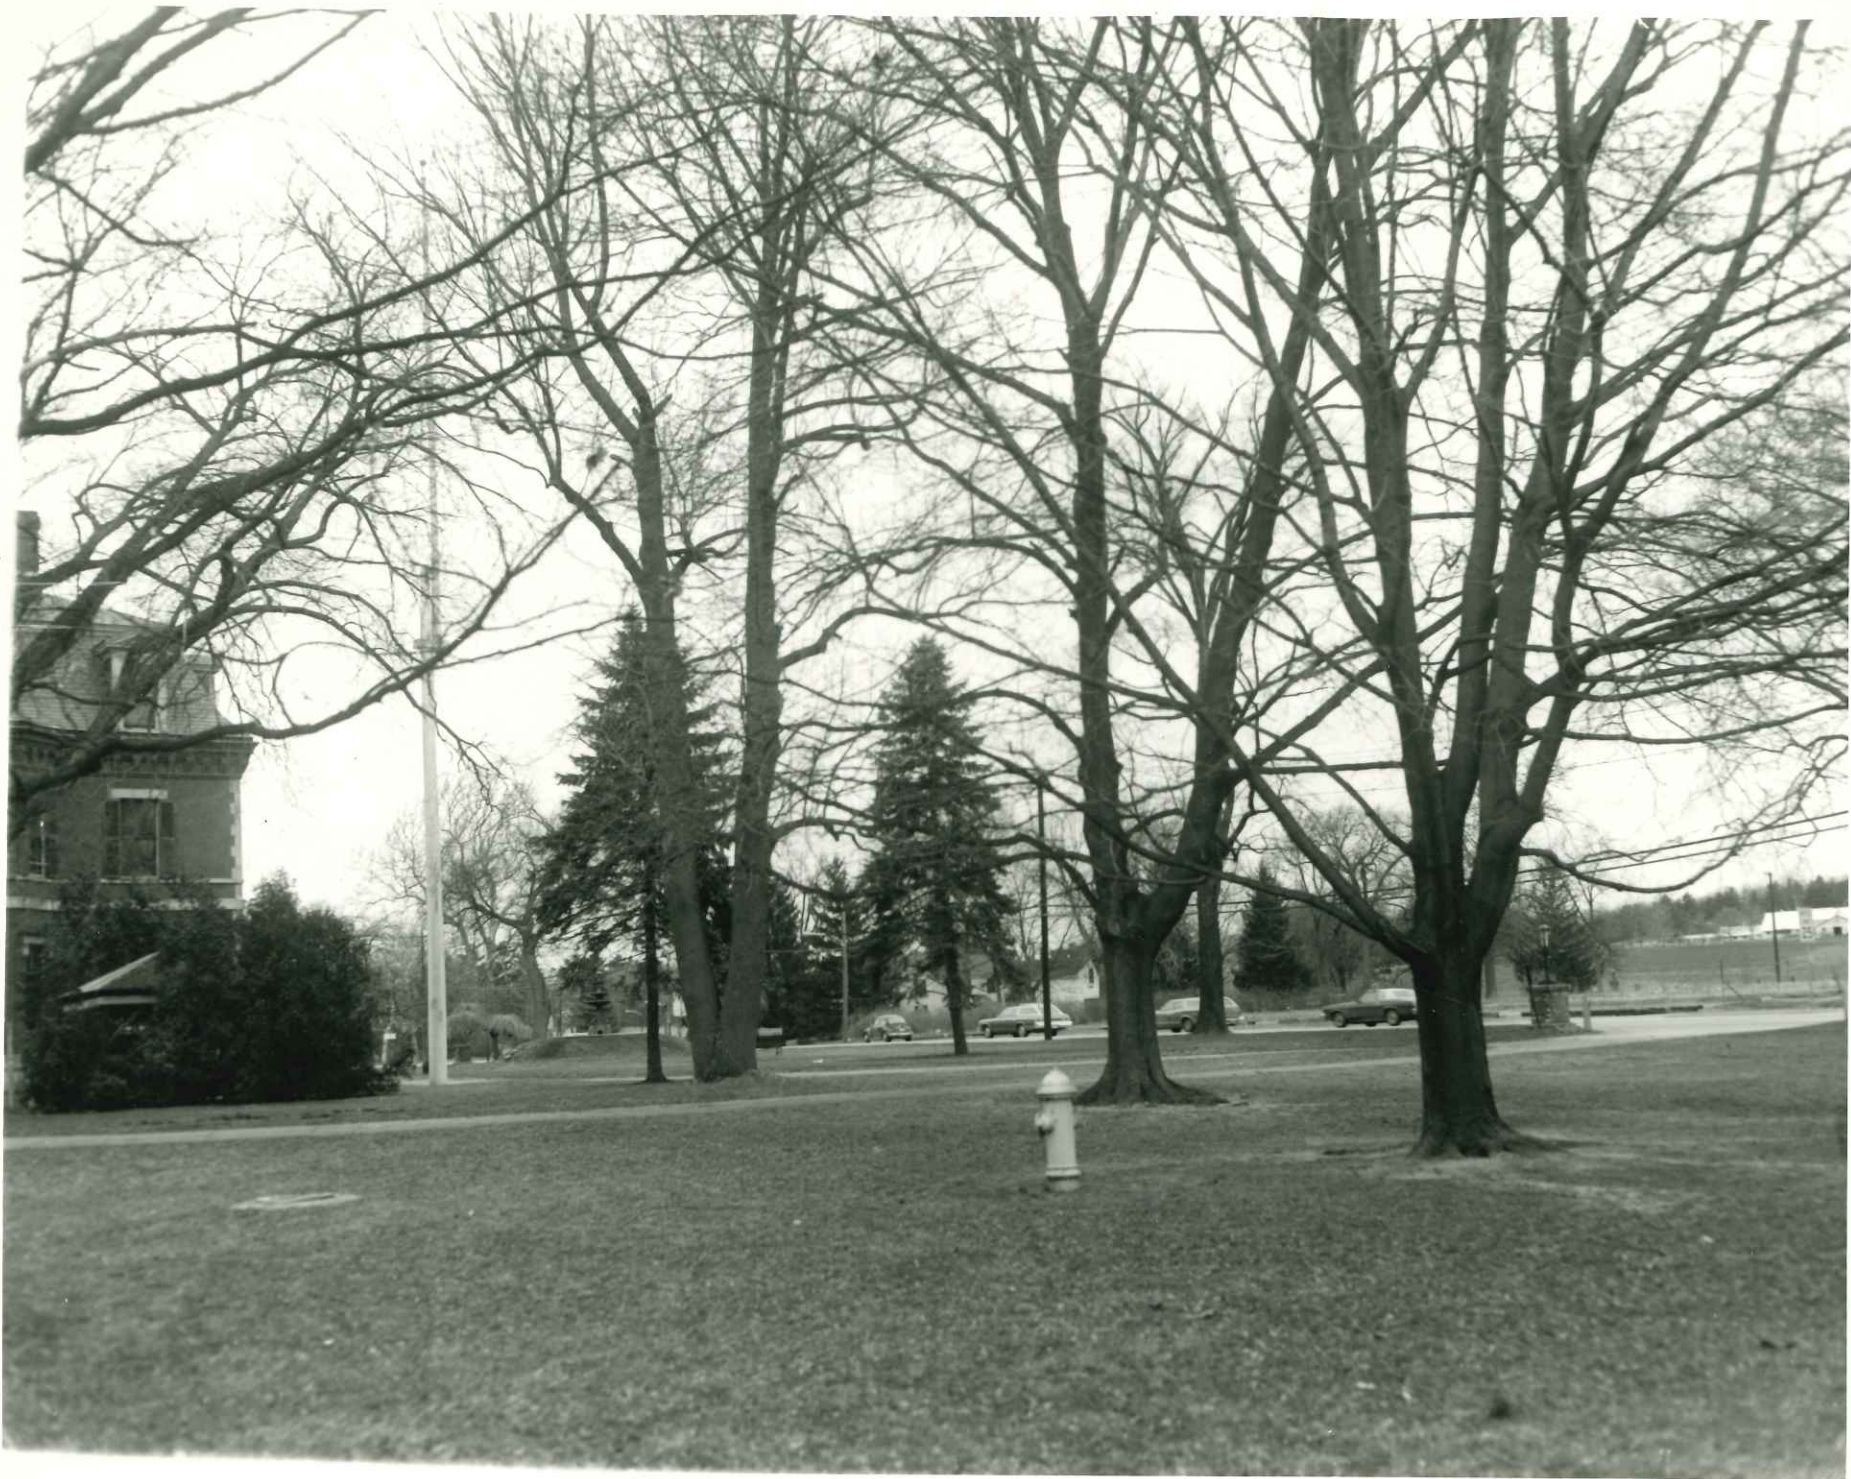
9, Massachusetts State Reformatory at Concord. Looking north west from prison lawn, Warden's residence (1 on sketch map) with gazebo at left, showing landscaping, State Route 2 and surrounding area.

DESCRIBE VIEW, DIRECTION, ETC. IF DISTRICT, GIVE BUILDING NAME & STREET
Looking northwest from prison lawn, Warden's residence (1 on sketch map) with gazebo at left, showing landscaping, State Route 2 and surrounding area. PHOTO NO. 9

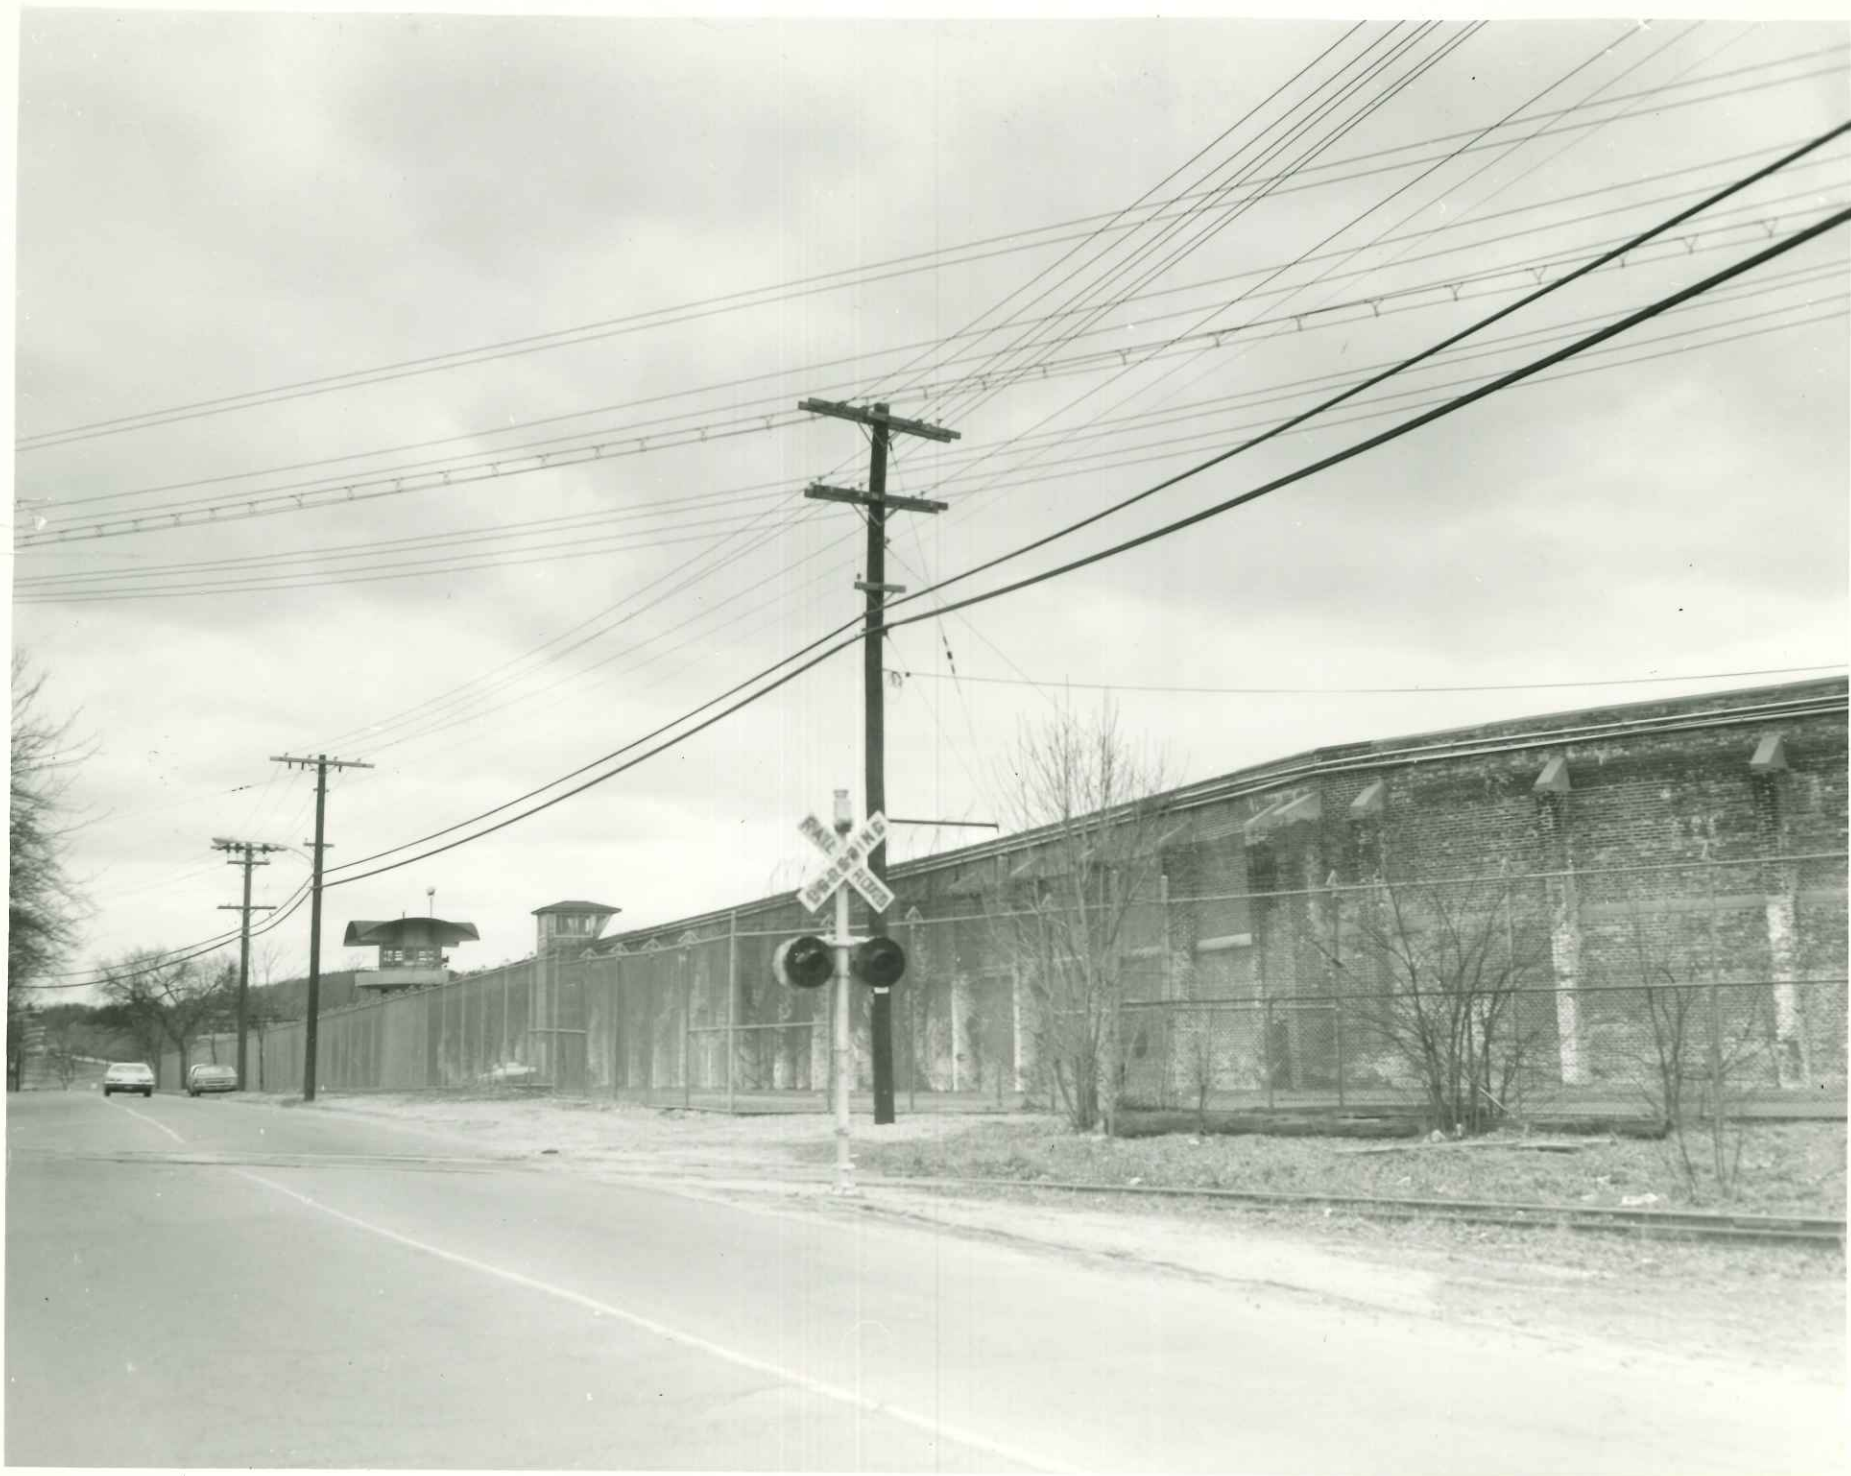
PHOTO NO. 10

10. Massachusetts State Reformatory at Concord. Prison wall (5 on sketch map) showing new tower, looking north east. Commonwealth Avenue in the foreground.

Prison wall (5 on sketch map) showing new tower, looking northeast. Commonwealth Avenue in the foreground.

Extending from the end of the wing to surround the main compound is a high wall (5) of simple brick panels between heavy brick posts on a granite foundation. Modern guard towers have been added to this wall at several points. The whole complex is fronted by a rather formally landscaped lawn with tall trees. A curved drive with formal entrance posts defines the area in front of the entrance building, where a handsome fountain sits on a central mound, flanked by mulberry trees. Landscaping around the house is mostly evergreen, with a gazebo on the warden's side.

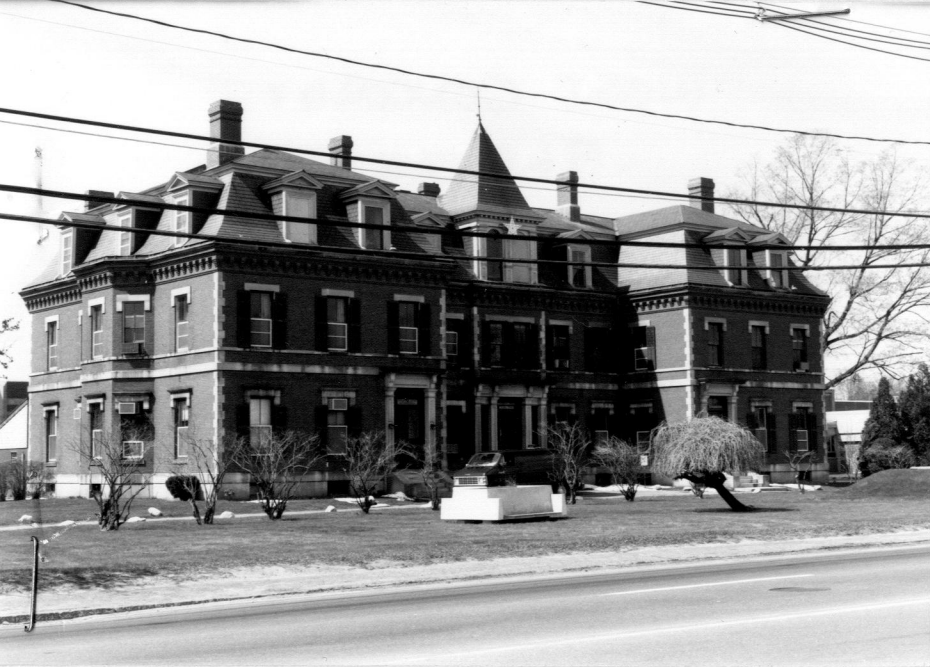
278
H51

City West Concord
Address 965 Elm St.
Historic Name Wardens' /Superintendents'
House--State Prison/Mass. Reformatory
Use: Present Offices
Original Residences/offices

DESCRIPTION
Date 1878
Source State Documents
Style Second Empire
Architect George Ropes
